EARTHQUAKE EFFECTS ON HISTORICAL MASONRY BUILDINGS  
IN ÜSKÜDAR

Orçun Nazım Temel

Submitted to the Institute for Graduate Studies in  
Science and Engineering in partial fulfillment of  
the requirements for the degree of  
Master of Science

Boğaziçi University

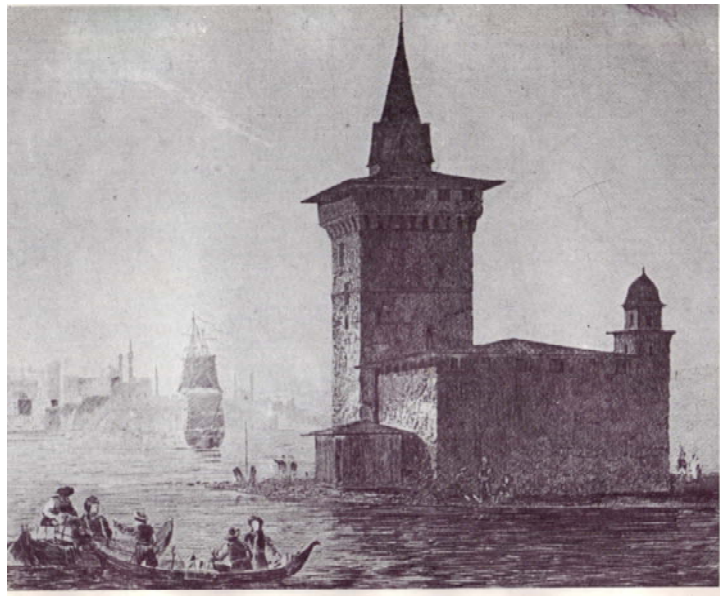
**Figure 4.2** Maiden's Tower Before 1453

This structure, which was built as a defense tower, was named Arcla, meaning "Small Tower". Although there is no clear information about this structure, it is believed to be close to its current dimensions. The tower, which was used for defense purposes during the conquest of İstanbul, was used for very different purposes after 1453. During the Ottoman period, it was used rather as a show platform, than a defense team and the Mehteran team cited the *nevbet* (a national anthem) accompanied by the canons placed on the island. [20]

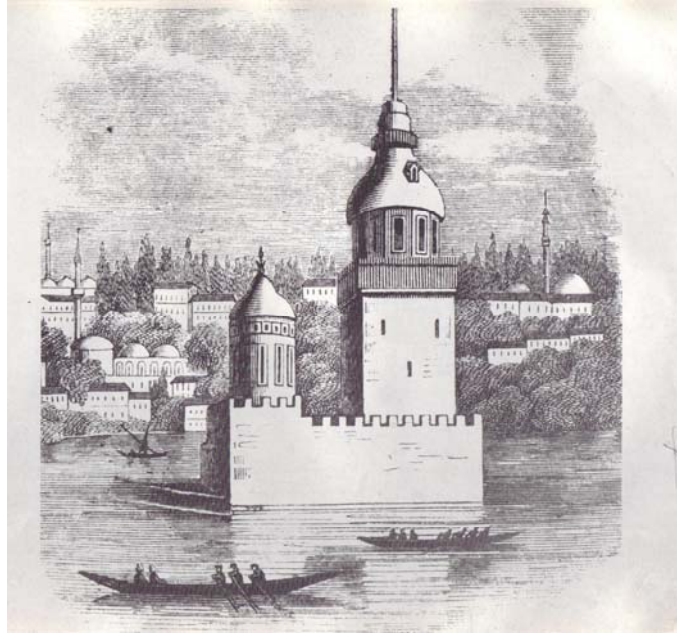
**Figure 4.3** Maiden's Tower before 18<sup>th</sup> Century

The structure, which was damaged during the earthquake of 1509, was rebuilt later. Furthermore, it acted as a lighthouse with the lights that were added. The structure that was built then included a tower and a castle, and a cistern was built in it.

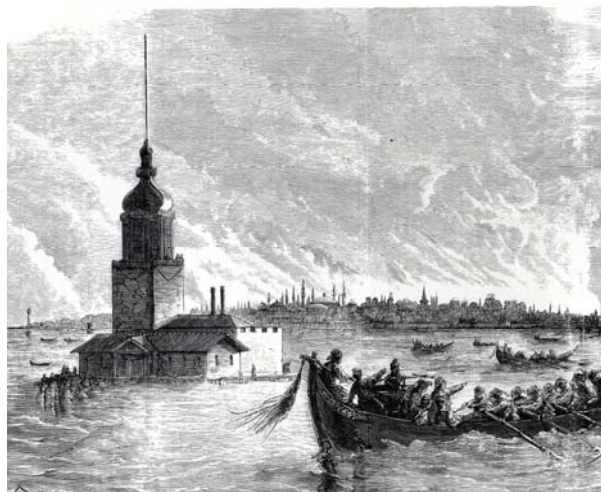
**Figure 4.4** Maiden's Tower at 19<sup>th</sup> Century

The tower that burnt down with the fire from the light, in 1719, was repaired again in 1725 by Nevşehirli Damat İbrahim Paşa who is the Head Architect of the city. The tower section was changed a little, and a glass chalet was added to the top, and a lead dome was placed on it, and the building was built with wood. It was converted into a quarantine hospital in order for the cholera epidemic not to spread to the city in 1830.

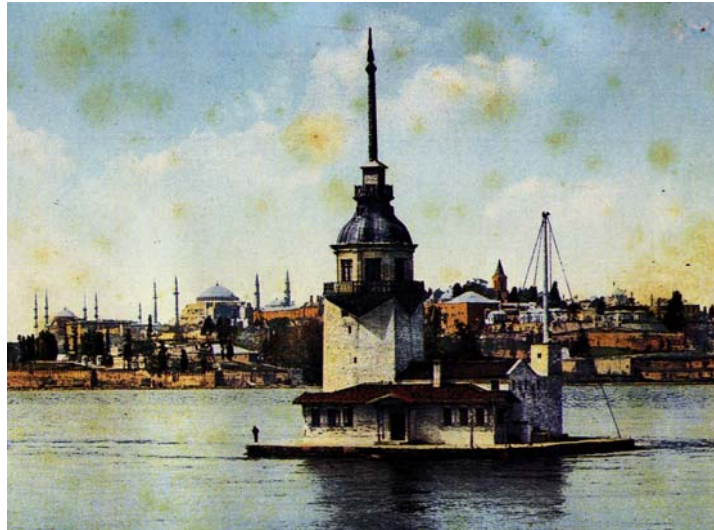
**Figure 4.5** Maiden's Tower at 20<sup>th</sup> Century

It was started to be used as a defence castle again with the decline of the Ottoman Empire, and it is equipped with canons. The epigraph bearing the signature of Sultan Mahmut the Second was placed on the marble above the gate, with the handwriting of the famous calligrapher Rakim. In 1857, a light is added again, and in 1920, an automatic system is introduced as the light of the lighthouse.

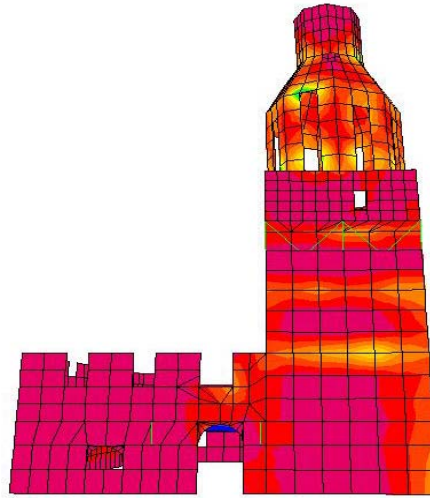
Figure 4.35, figure 4.36, figure 4.37 and figure 4.38 shows the stress values occurred from East-West direction earthquake forces.

**Figure 4.35** AR East-West Direction Earthquake Force, East Side Stress Results

**Figure 4.36** AR East-West Direction Earthquake Force, North Side Stress Results

**Figure 4.37** AR East-West Direction Earthquake Force, South Side Stress Results

**Figure 4.38** AR East-West Direction Earthquake Force, West Side Stress Results
