**EARTHQUAKE PROTECTION OF BEYLERBEYI PALACE BY
REVERSIBLE MIXED TECHNOLOGIES**

**BOGAZIÇI UNIVERSITY
2007**

Submitted to the Institute for Graduate Studies in
Science and Engineering in partial fulfillment of
the requirements for the degree of
Doctor of Philosophy

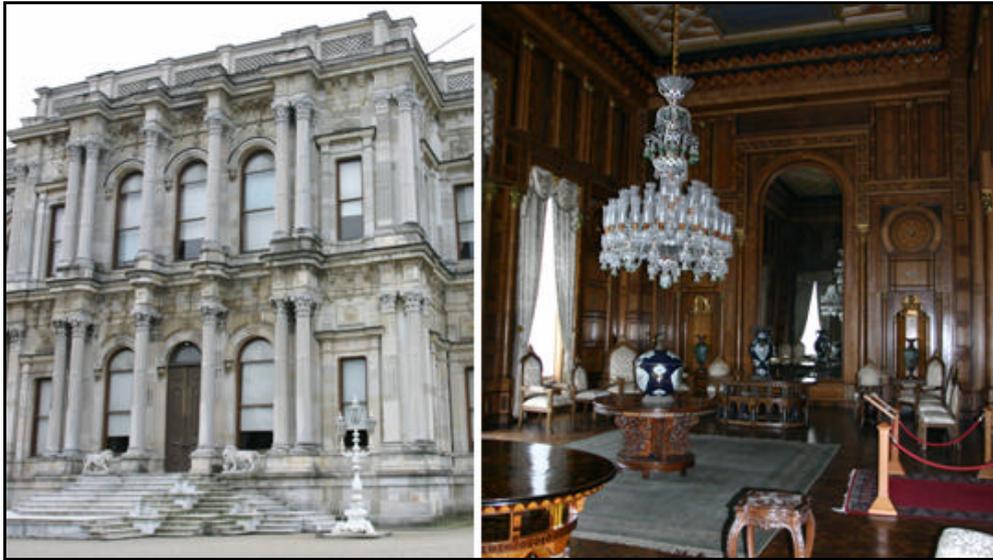
The 19th century Beylerbeyi Palace illustrates the distinct western influence on Ottoman architecture over this period. Many European architects who worked in Anatolia during that century played a part of that influence which is clearly seen in the palaces of Dolmabahçe, Çiragan and Beylerbeyi. While the exterior side of Beylerbeyi palace reflects the western architectural style, the interior plan complies with traditional Turkish vernacular architecture (Figure 2.9). The exterior façade is covered by küfeki stone. On the interior wall surface of Mabeyn part, special stucco plasters with drawings and wood covering with carvings are used while Harem part walls are cover with normal plaster and paintings [10].

Figure 2.9. Western interaction on exterior façade versus Turkish interaction on interior face

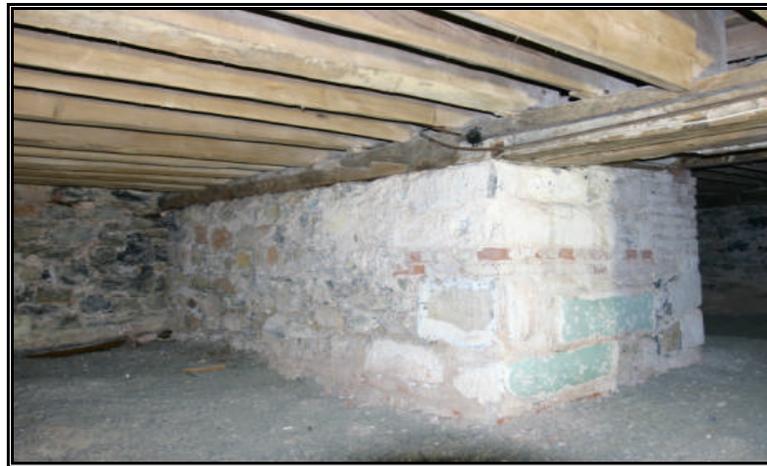
Three-story structure is mainly made of masonry walls and timber slabs. The basement floor of the Harem part enables to identify the masonry which is composed of lime mortar and stones. This part of the palace has no architectural function thereby no plaster was used and system is clearly seen. The timber floor is also visible. Thicknesses of the walls are changing between 2 m and 1 m and it is often 1.4 m on that floor. These walls are also forming the foundation system of the palace. Figure 2.13 shows the details from that floor.

Figure 2.13. Foundation of the palace

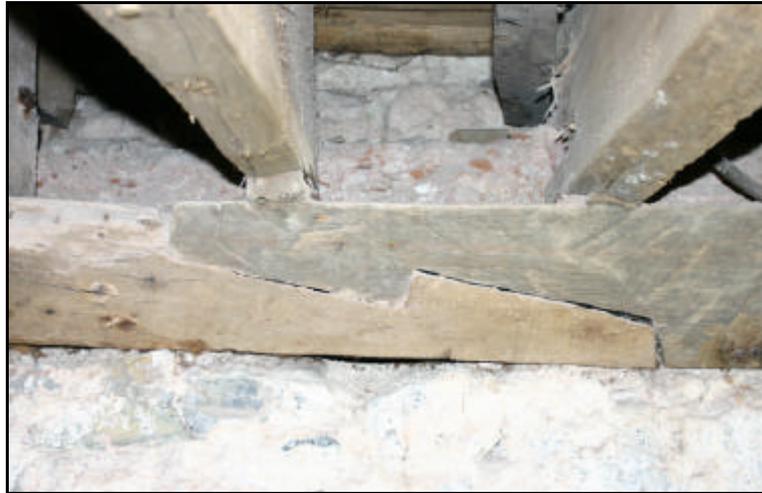
It is determined that the slab of the structure is mainly composed of two types of timber cross-sections. 20*20 cm² beams (supporting beam) were located on the masonry walls and 8*40 cm² beams (slab beam) with 40 cm spacing lie between two walls perpendicular to wall direction. Oak was used for the supporting beam while slab beams were produced from fir. Details can be seen in Figure 2.14.

Figure 2.14. Splice of timber beam between the structural wall and slab girders

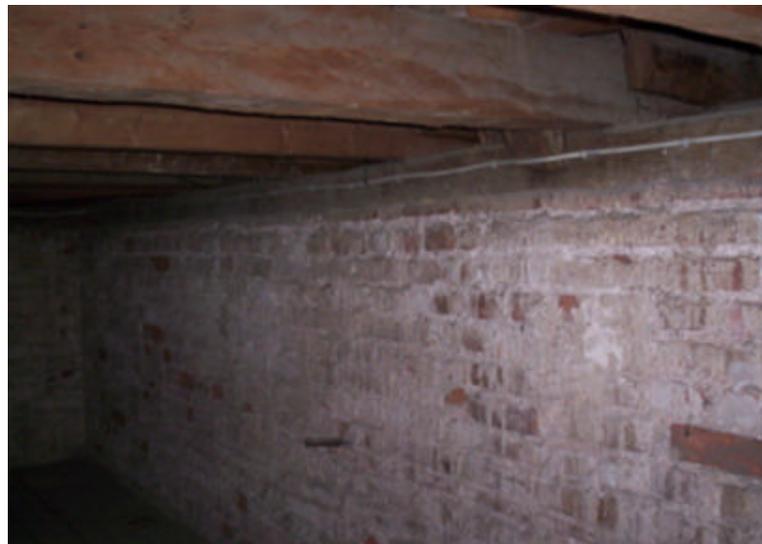
The roof of the palace verifies the slab configuration in the basement. On the other hand the first story slab configuration could not be examined. Figure 2.15 illustrates the interior side of the roof of the palace.

Figure 2.15. Structural wall and timber slab in the roof of the structure

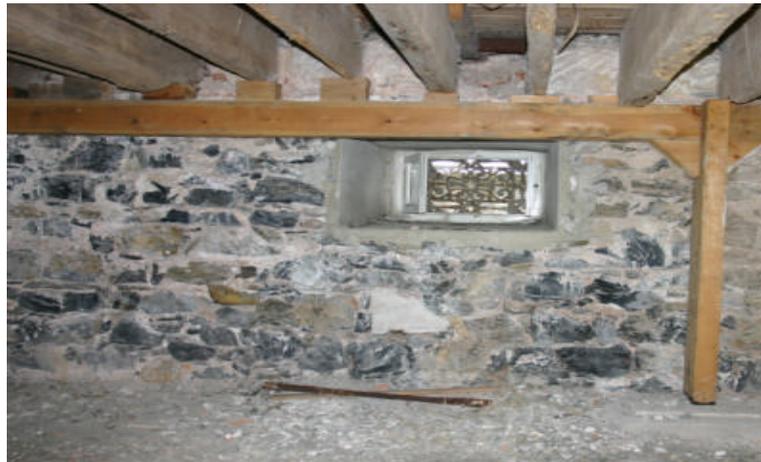
Damage survey of the basement storey revealed the existence of high humidity level although it has several ventilation openings (Figure 3.1). Especially Harem part of the basement has been affected and snowy segments took form on the surface of stones as proven by Figure 3.2. The high level of humidity affected both the timbers slab system, by causing decay and masonry walls by affecting the mechanical properties. In order to prevent the propagation of decay on timber members, affected parts were chipped and some members were replaced by new timber beams during the restoration works (Figure 3.3). For the prevention of high humidity which causes deterioration of stone, mortar and timber, ventilation of the basement floor with suitable machinery equipment can solve the problem. Recent studies have revealed the efficiency of the ventilation against high humidity [11].

Figure 3.1. Ventilation opening in the foundation floor

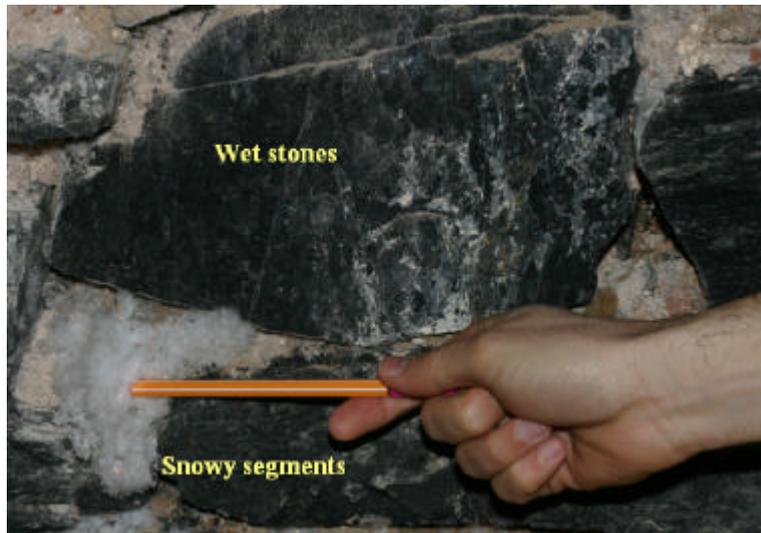
Figure 3.2. High humidity over stones and its effects

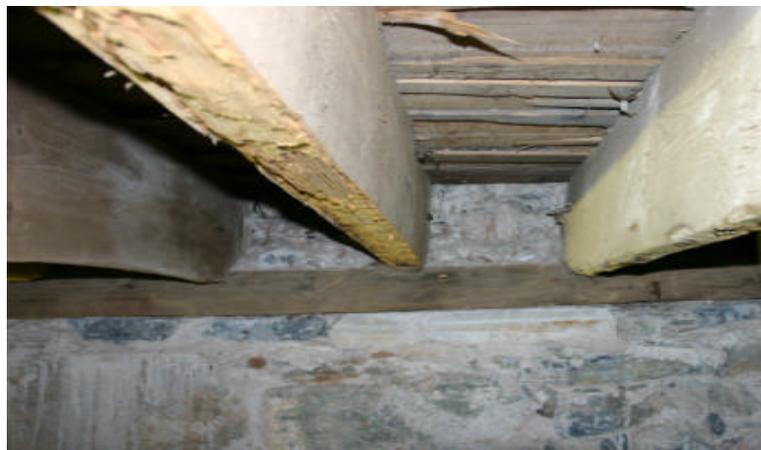
Figure 3.3. Chipped timber beams due to decay on the foundation floor

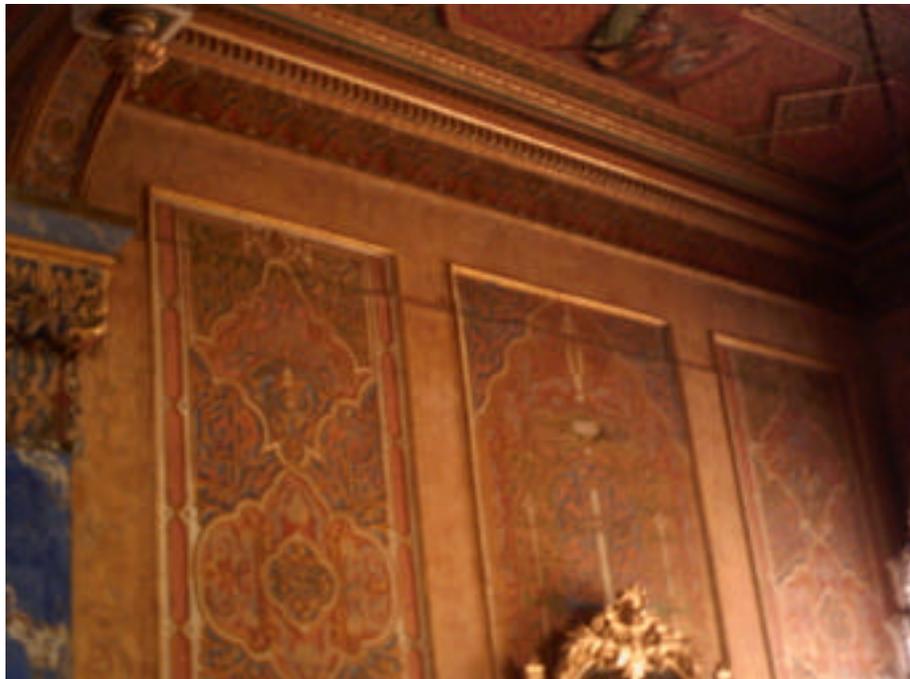
In the first and second floors of the structure several cracks were observed. Since no restoration process has been carried out in the mabeyn part of the palace, everything is original on the other hand in the harem part of the palace repair works were performed to cover the cracks. For that reason most of the detected cracks are in the mabeyn part on the stucco plaster. Since the reproduction of stucco plaster is impossible nowadays, authorities do not touch the cracks to repair them. Similarly the timber coverings of the rooms in mabeyn part have very wide cracks which are hard to interpret the effect of them over structural safety. If the cracks stem from the damage occurred on the wall beneath the covering, special care must be spent. Other wise they only disturb the beauty of the rooms. Through Figures 3.4 - 3.6 the observed cracks are shown. The cracks can be classified into three categories. These are;

Figure 3.4. Horizontal crack in the Mabeyn part

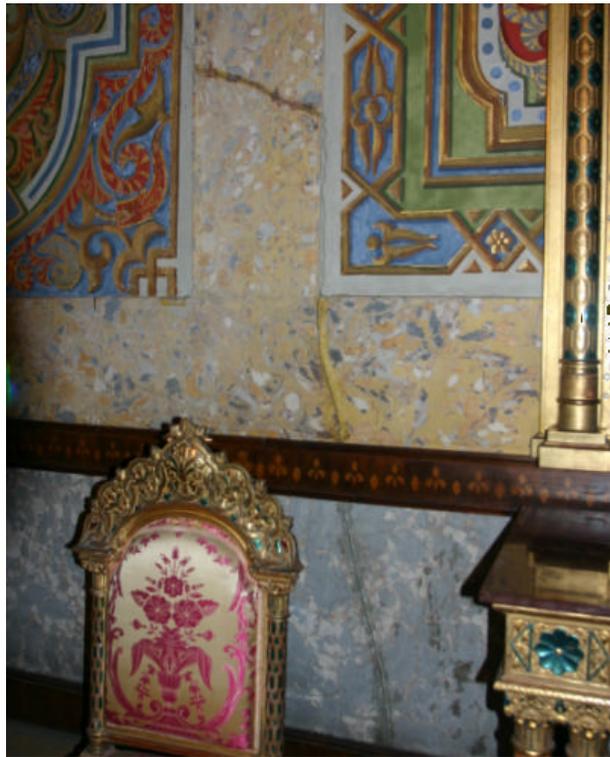
Figure 3.5. Vertical crack in Mabeyn part

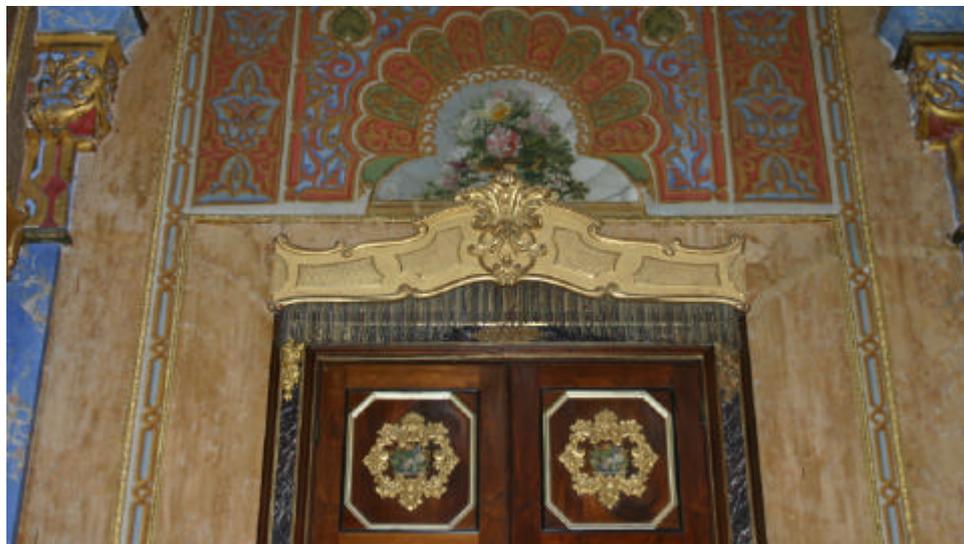
Figure 3.6. Inclined cracks on the corners of the door

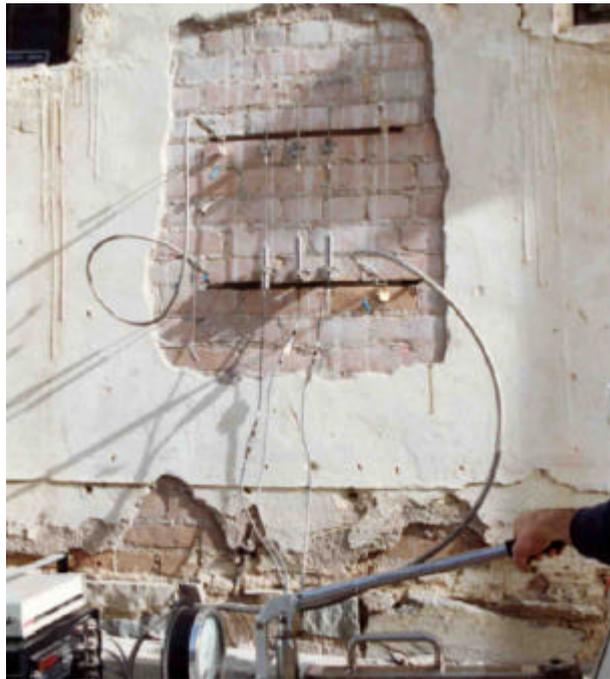
The deformation properties of masonry may be evaluated by inserting two parallel flatjacks, one directly above the other separated by several courses of masonry, and pressurizing them equally, thus imposing a compressive load on the intervening masonry. The deformations of the masonry between the flatjacks are then measured for several increments of load. The results are used to calculate the masonry deformability modulus. If some damage to the masonry is acceptable, the masonry may be loaded to failure to determine the maximum strength [12]. Figure 3.7 shows the application of double flatjack test over an existing masonry structure [13].

Figure 3.7. Application of double flatjack testing method on a masonry wall [11]

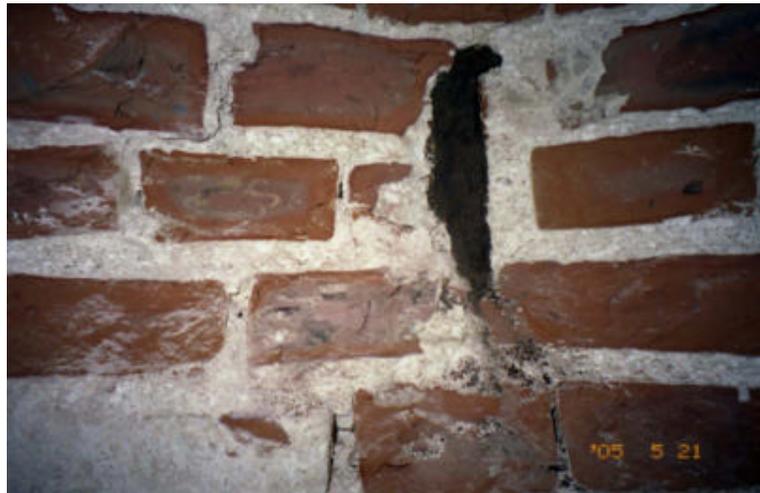
Figure 3.8. Masonry configuration in the room of harem

The oxidation of metal clamps used within the masonry caused swelling and finally cracking of the wall in a room and stair case in harem part. This damage ended up with the separation of about 50*50 cm² wall part in the room. This event enabled us to determine the masonry configuration and have ruins from the original mortar of the structure. Both mortar and plaster particles were taken to analyze the origin of the mortar. The average mortar thickness is about 18 mm and brick height was measured as 65 mm. Figure 3.8 and 3.9 show the masonry configuration in the room and stair case in harem part respectively

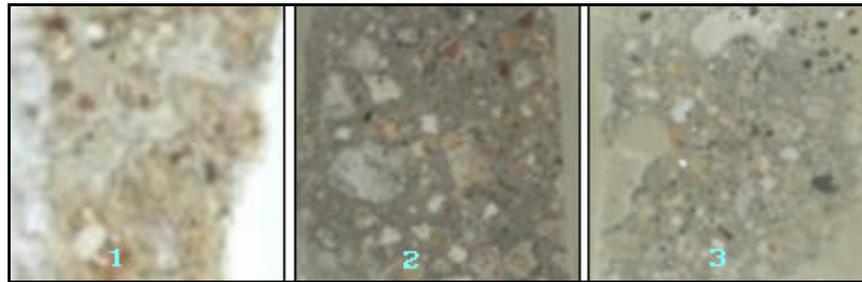
Figure 3.10. Thin-sections

3.2.2.1. Thin Sections, under Polarizing Microscope. For the characterization of mortar, the study of thin sections under the polarizing microscope is a very efficient analytical technique. A thin section is made by grinding down a slice of rock which has been glued to a glass slide until it reaches a thickness of about 0.03mm (30 microns). At this thickness most minerals become more or less transparent and can therefore be studied by a microscope using transmitted light. In this study five thin sections were prepared and investigated. Figure 3.10 shows three enlarged views of the prepared thin sections and Figure 3.11 shows the photograph of the first thin section, taken under petrography microscope.

Thin-section analysis showed that, about 60% of the mortar is binding material and remaining part is the grains. The general grain size is about 500 μm and less. It occasionally reaches to 1 mm. These grains contain mineral particles, quartz particles and clearly identified brick powder particles. Table 3.2 summarizes the identified ingredients of the thin-sections.

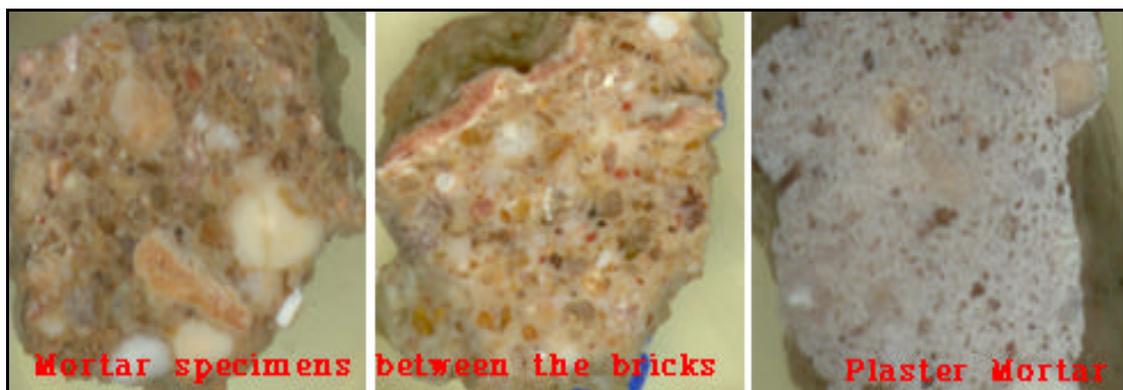
Scanning Electron Microscope is a widely used technique to study surface topography. The mortar specimens were searched under Philips XL30ESEM-FEG&EDAX, Environmental Scanning Electron Microscope and Energy Dispersive X-Ray device. Figure 3.12 shows the polished specimens. The first two specimens with bigger grain size belong to the mortar taken between the bricks and the third one is the plaster mortar. Mineralogical structure of the ingredients of the mortar were tried to be identified on enlarged views thanks to EDX.

Figure 3.12. Mortar specimens, prepared for SEM and EDX analysis

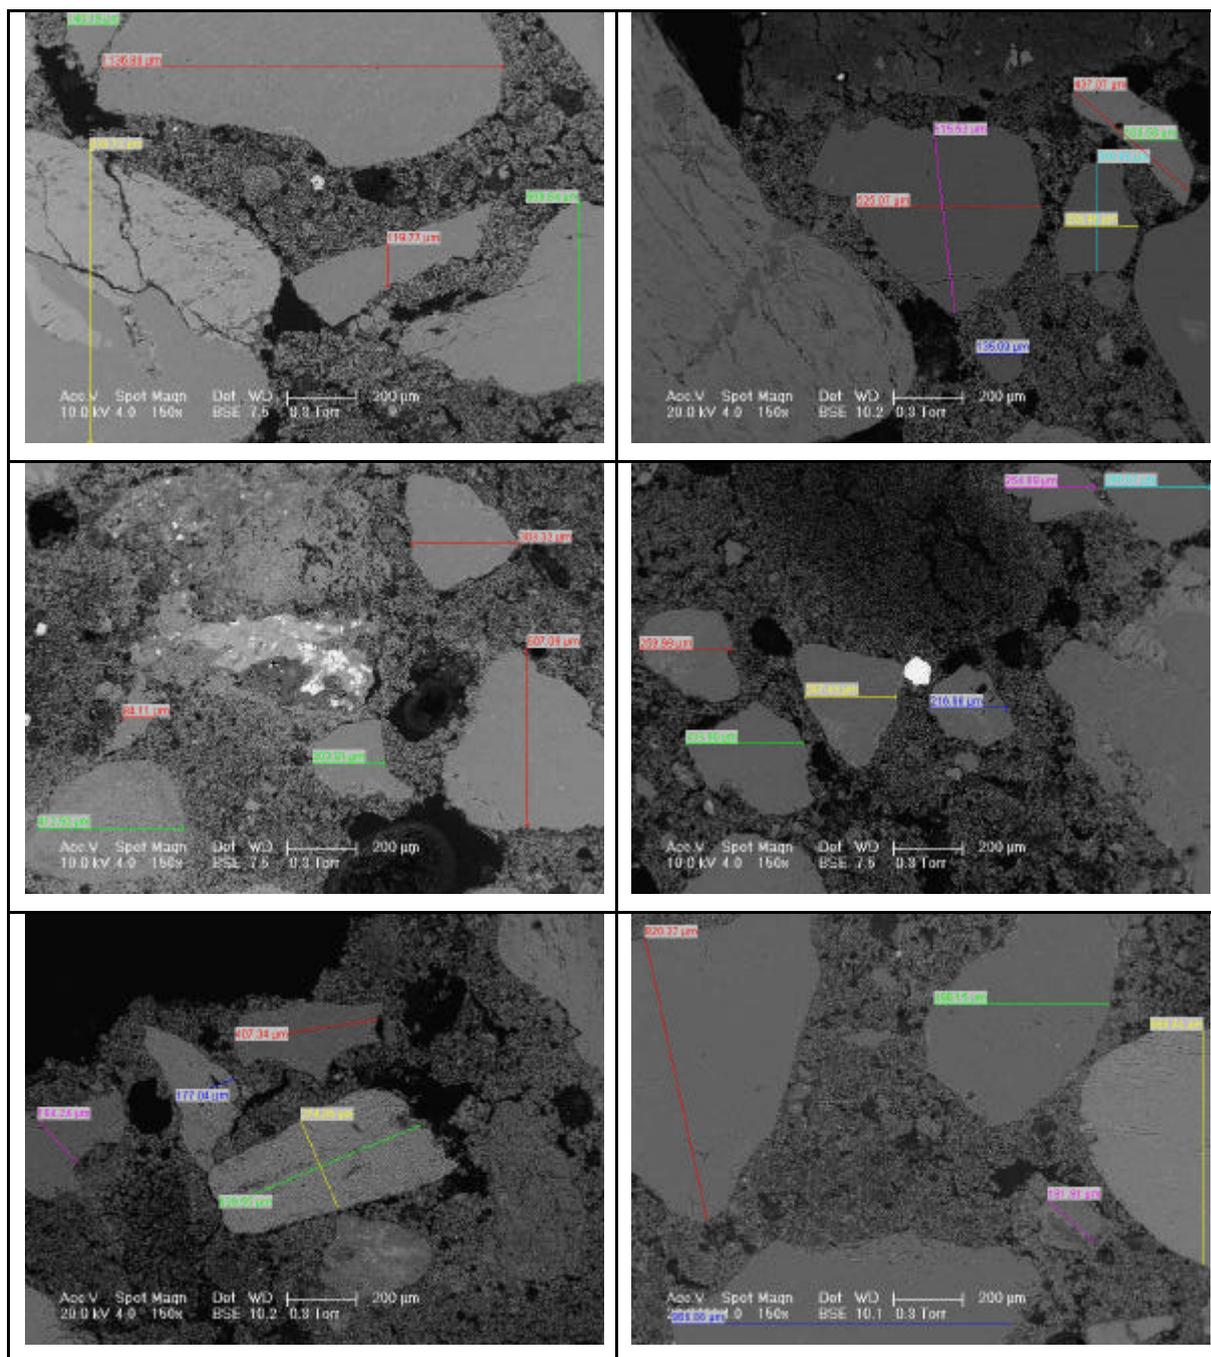
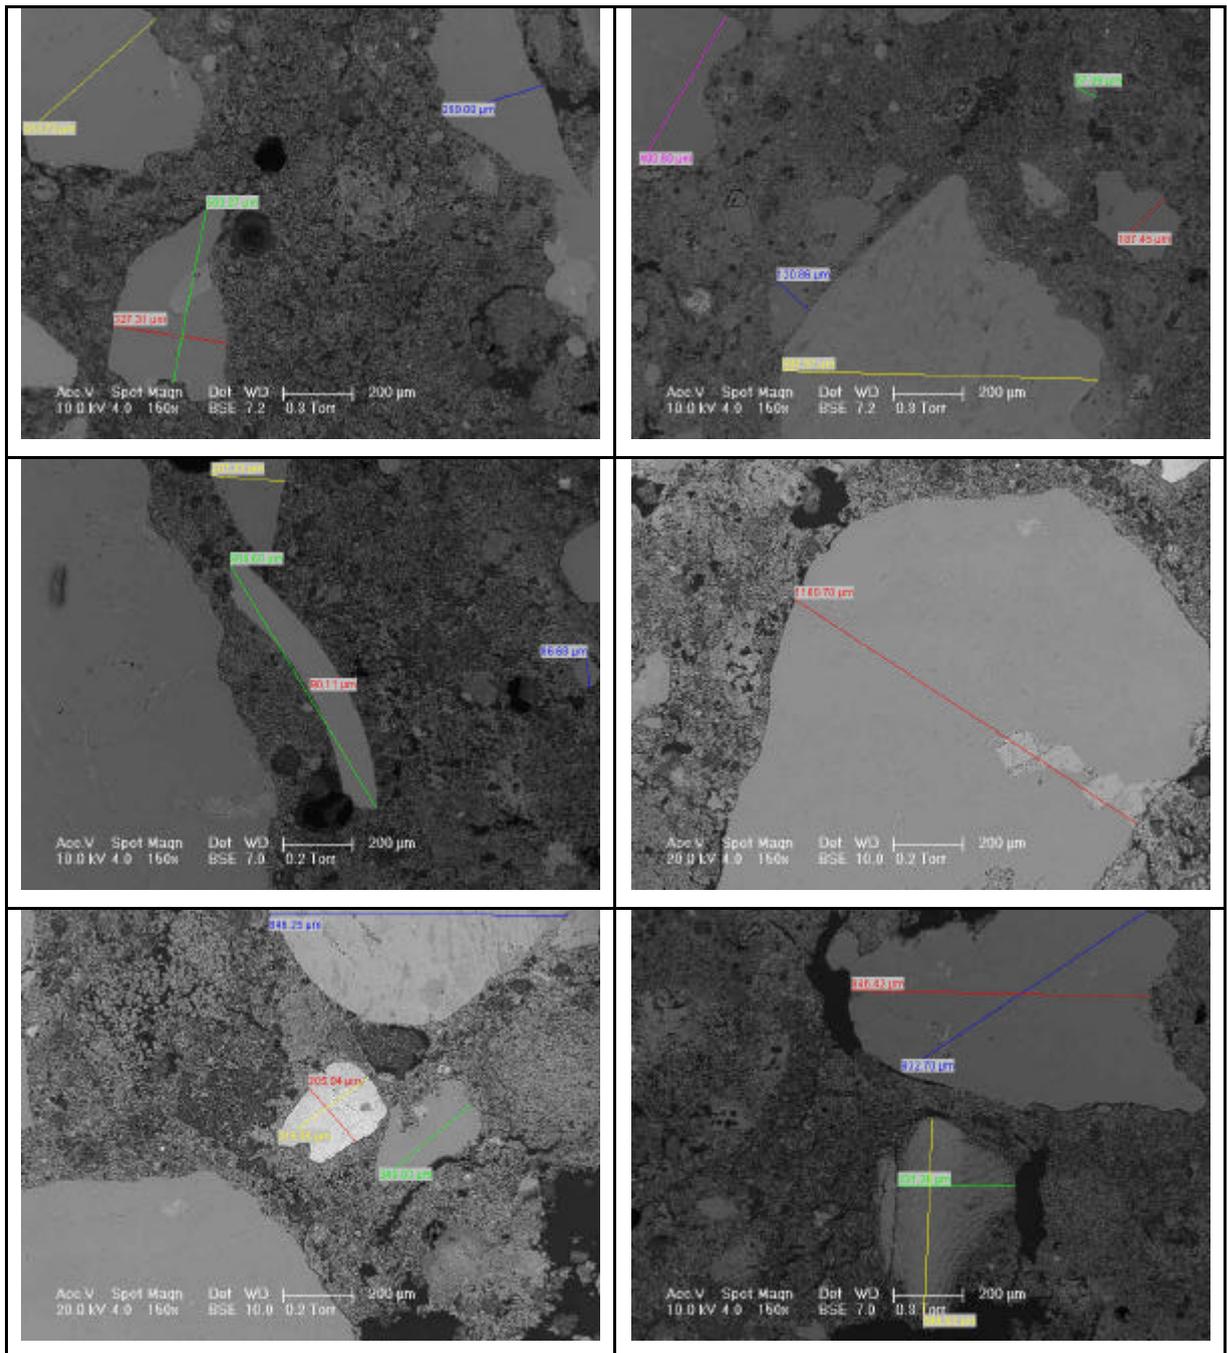
Figure 3.13. SEM views from the mortar between the bricks

Figure 3.14. SEM views from the mortar between the bricks

Good connection between particles and binding material was observed through the SEM views. No gap or cracks were determined. Particle size distribution can easily be determined from SEM views (Figures 3.13 – 3.15). It is seen that the grain particle size, used in mortar is grater than that used in plaster. According to SEM views the maximum size is determined as about 1800 μm.

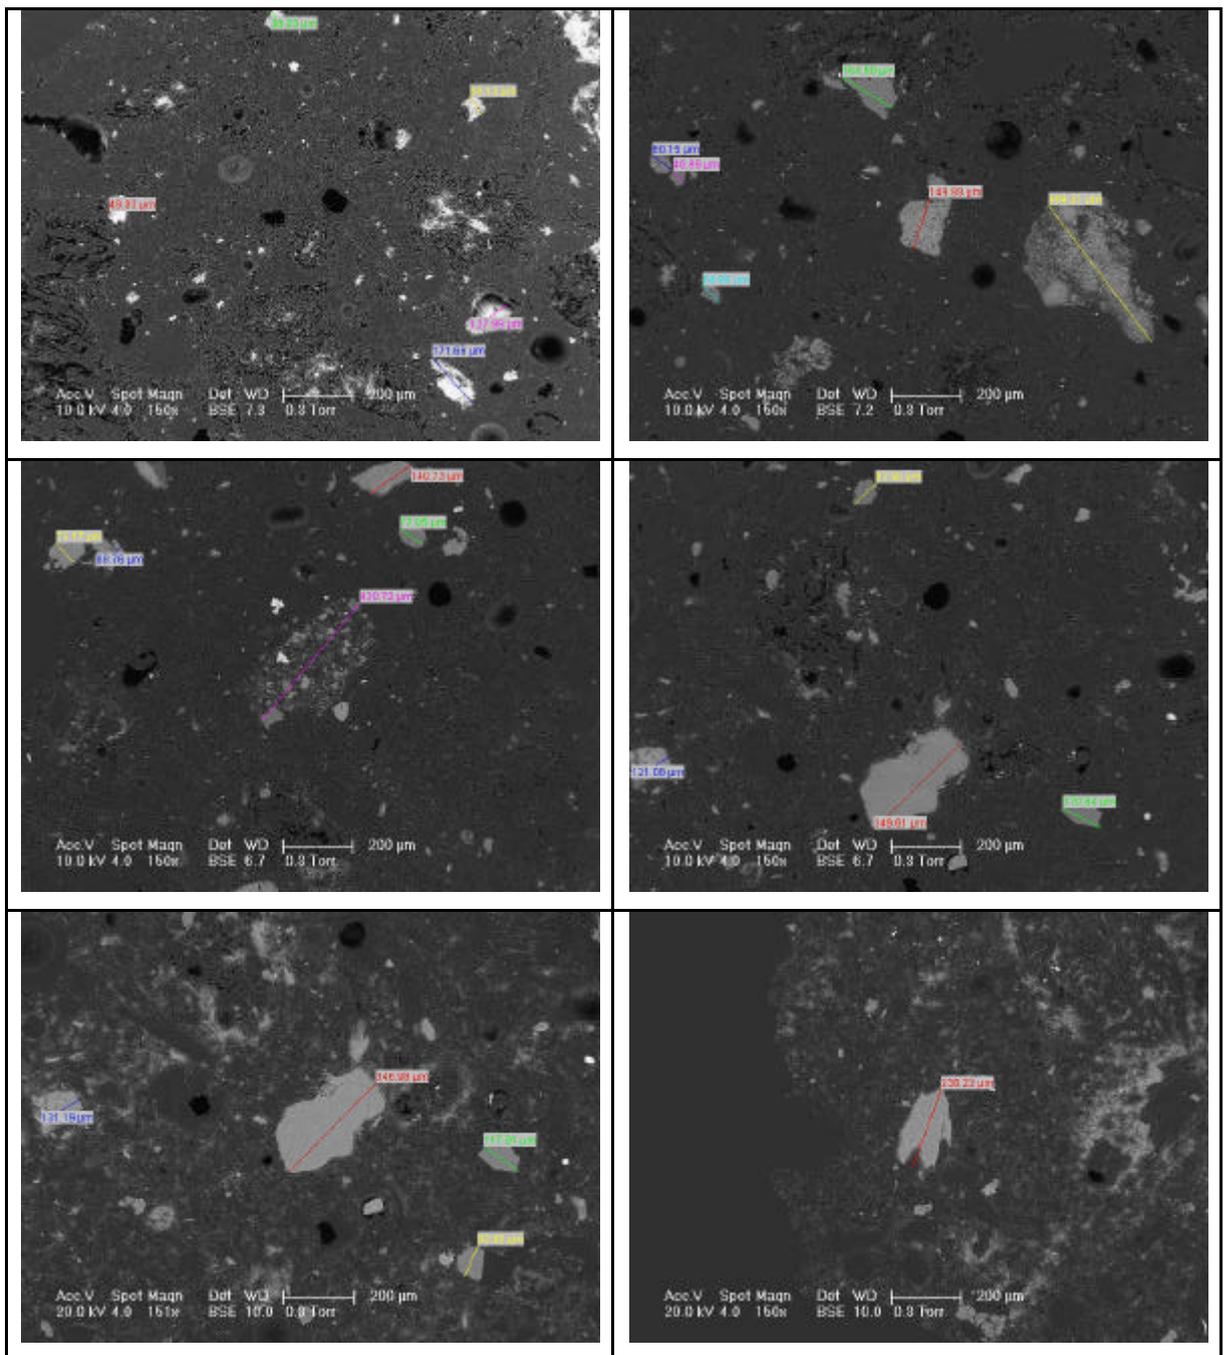
Figure 3.15. SEM views from the plaster

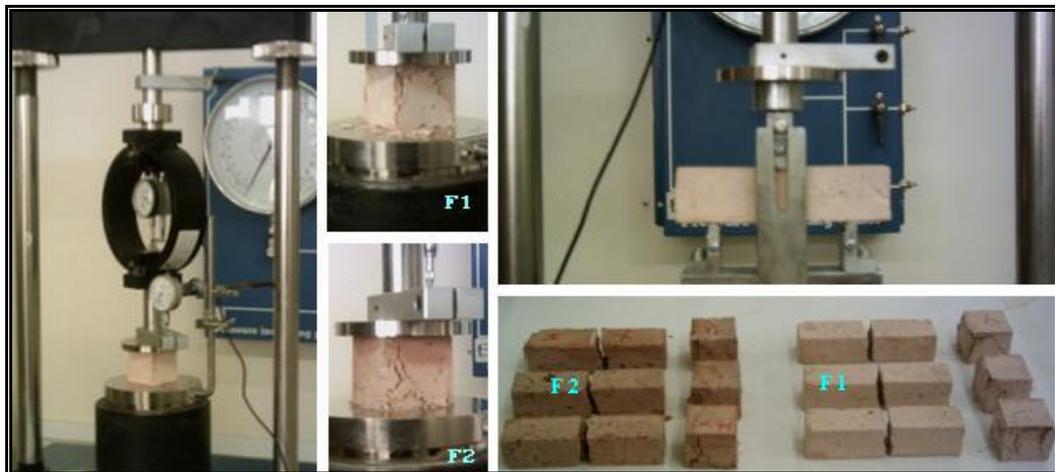
Figure 3.19. Compression and flexure tests and failure of the specimens

Flexure tests were also performed to determine the flexural strength of the mortar. For each mortar type three specimens were tested on three point flexure jig. The specimens have showed very brittle behavior and via single vertical crack, occurred just under the application point of the load they failed. Average flexural strength of the F1 and F2 are determined as 1.57 MPa and 1.71 MPa respectively.

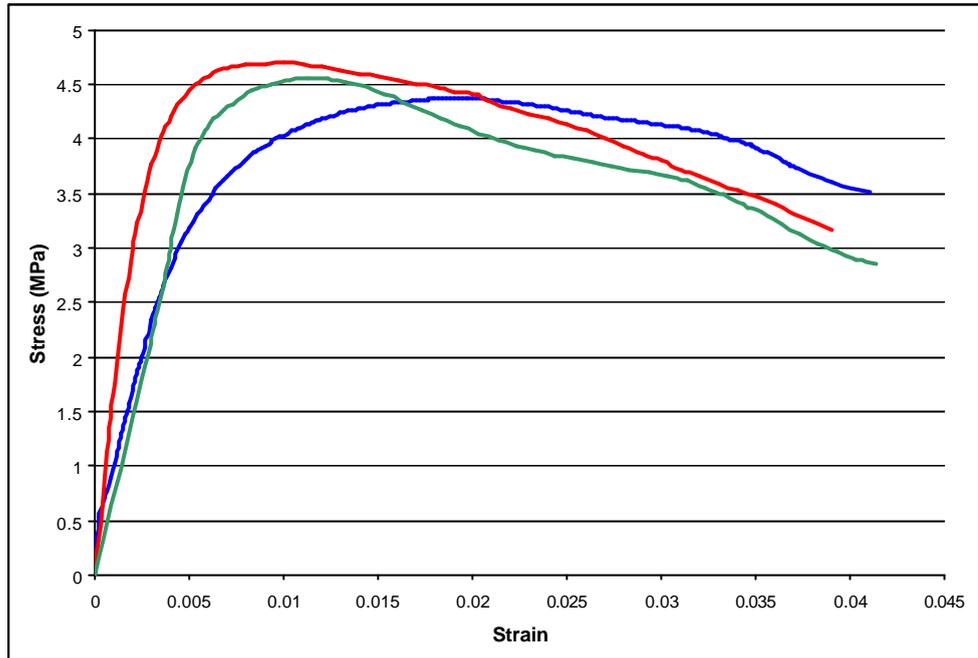
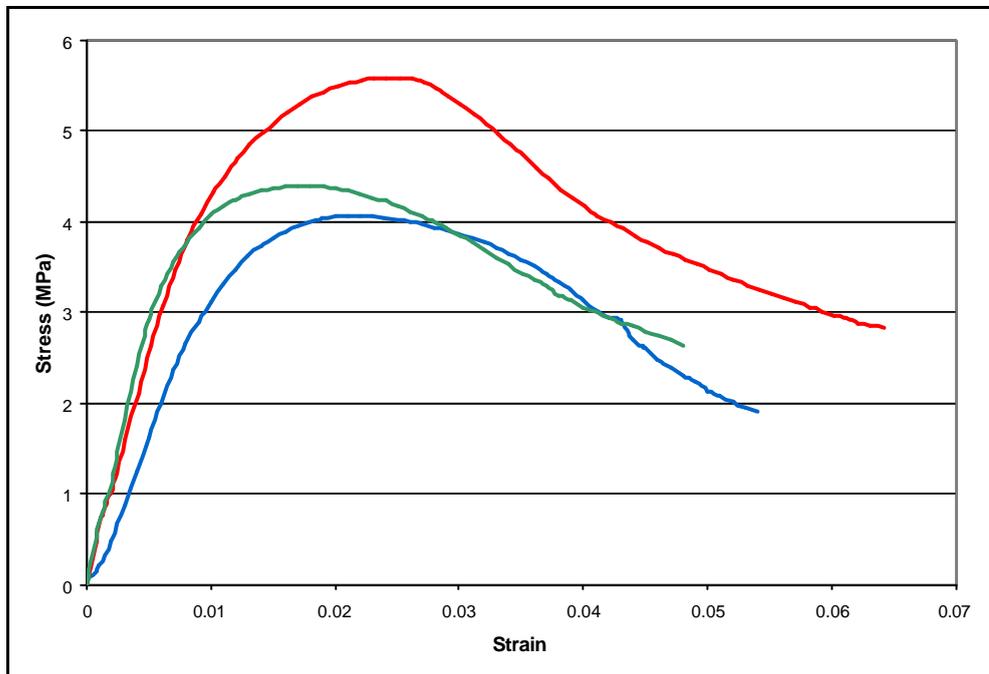
During the compression tests the applied load and measured displacement were recorded and stress-strain diagrams were obtained for each specimen. Figures 3.20 and 3.21 show the stress-strain diagrams for mortar produced with F1 and F2 formulas respectively. At the failure point similar crack patterns were observed for both types of mortar specimens. The average compressive strength for both kind of mortar is roughly the same and they are 4.54 MPa and 4.68 MPa for F1 and F2 respectively. On the other hand the strain capacities are different. The average ultimate strain for F1 mortar is measured as 0.04 while that is 0.055 for F2 mortar. Secant modulus of elasticity for mortars was also determined as the slope of the line intersects the origin and one third of the maximum stress on stress-strain curve of each specimen. Average modulus of elasticity for F1 was determined as 1127 MPa while it is 473 MPa for F2.

Figure 3.20. Stress-strain curves of the mortar specimens produced with F1

Figure 3.21. Stress-strain curves of the mortar specimens produced with F2

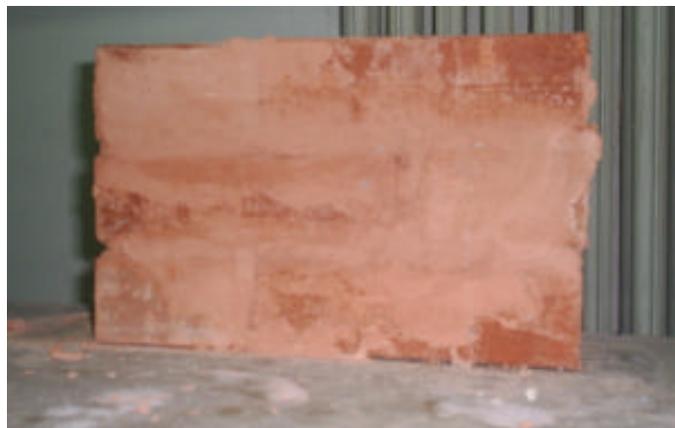
Three masonry specimens with F1 type of mortar formula and three masonry specimens with F2 type mortar formula were produced and tested after six month from the production (Figure 3.23). Normal clay burnt brick were used in the specimens. The tests were performed in the laboratory of Bogazici University. One load cell and two

Figure 3.23. Compression test specimen with 1.8 cm mortar height and 6.5 cm brick height

Within this study test specimens were created according to European Norm, EN 1052, methods of tests for masonry [22]. According to specification for the compression test at least three specimens of 1.5-unit length and 3-unit height should be tested (Figure 3.22). The characteristic compressive strength of masonry f_k is determined as the smaller value of either $f_k = f_{average} / 1.2$ or $f_k = f_{min}$ [22].

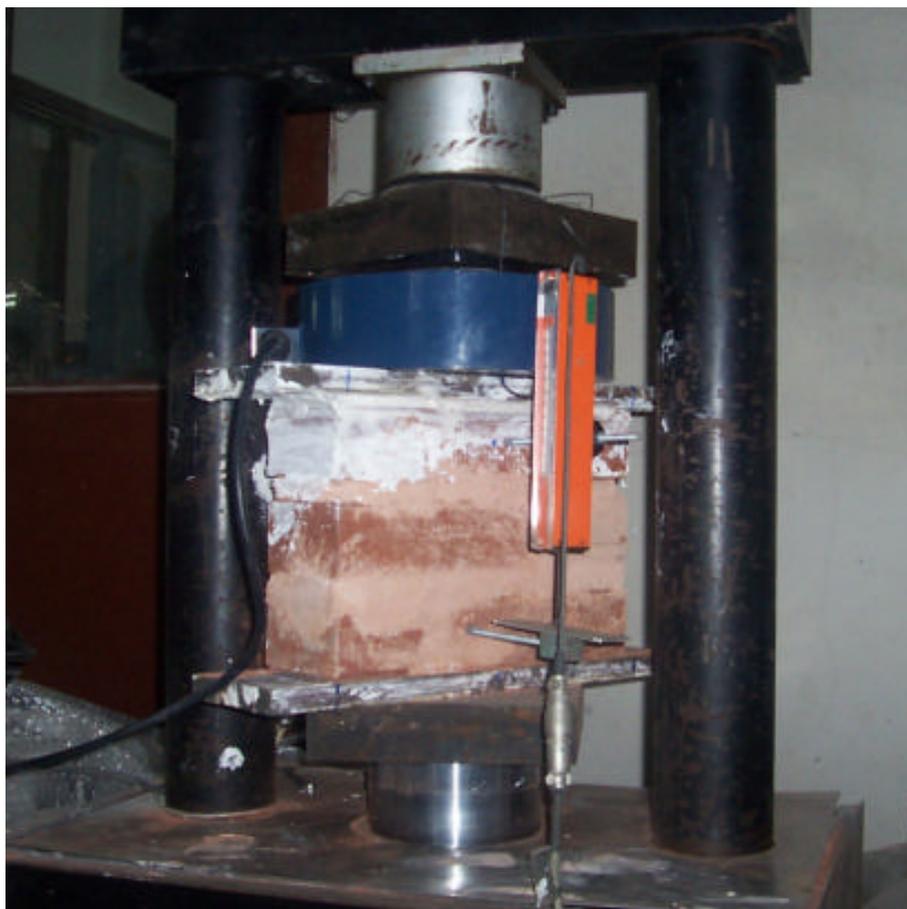
Figure 3.24. Testing of masonry specimen

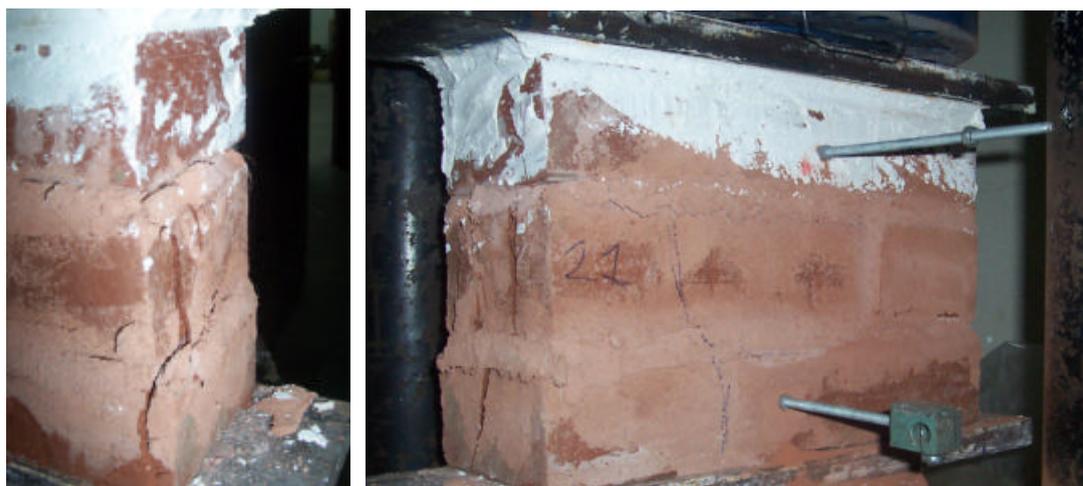
Figure 3.25. Failure of the masonry specimen

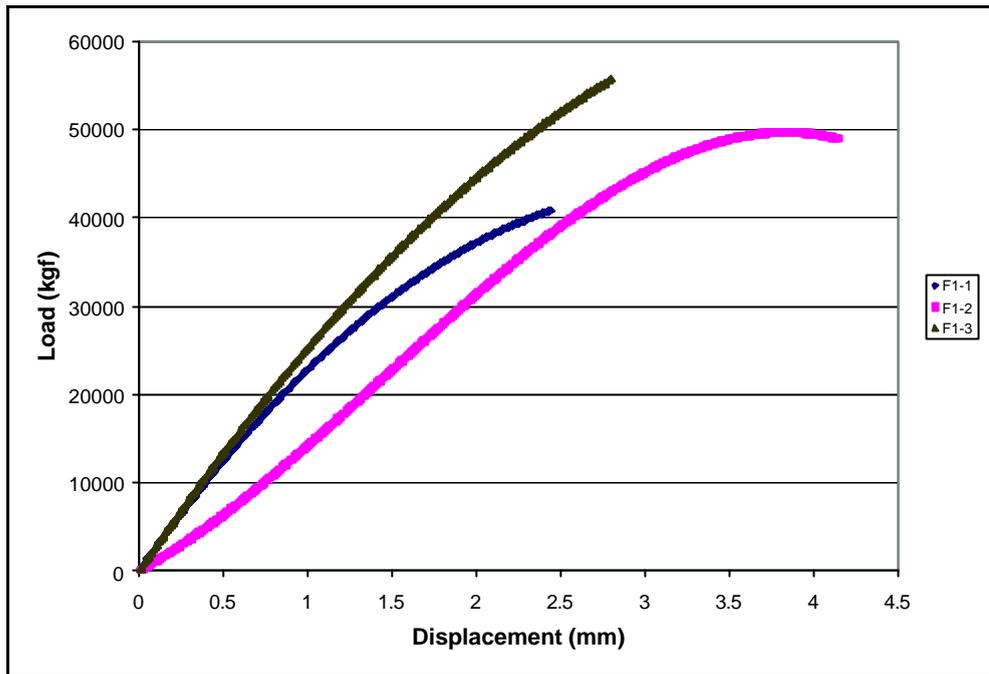
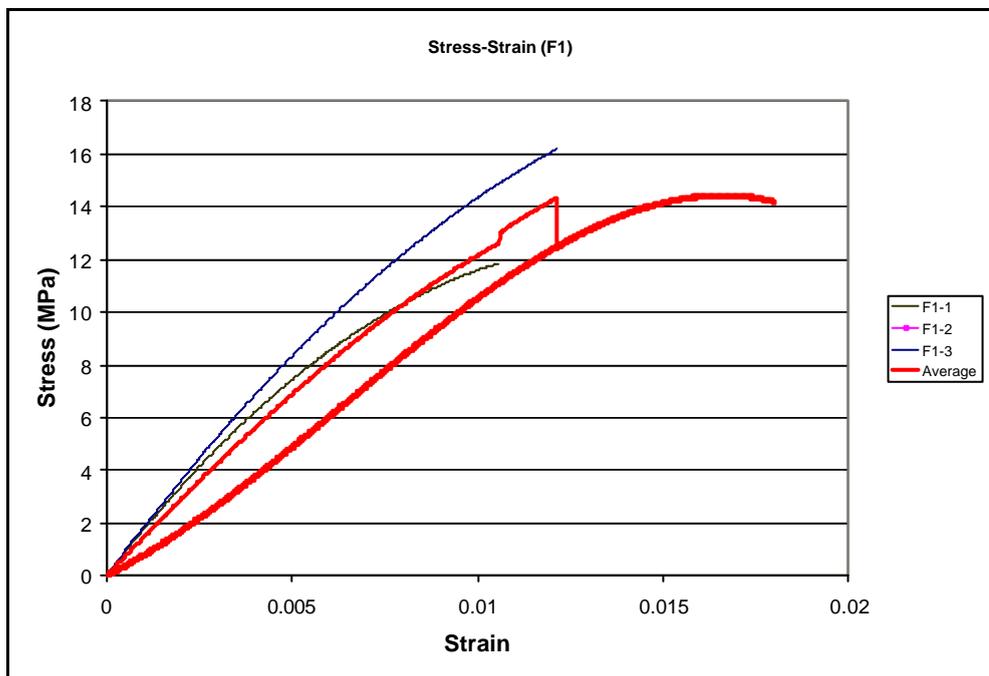
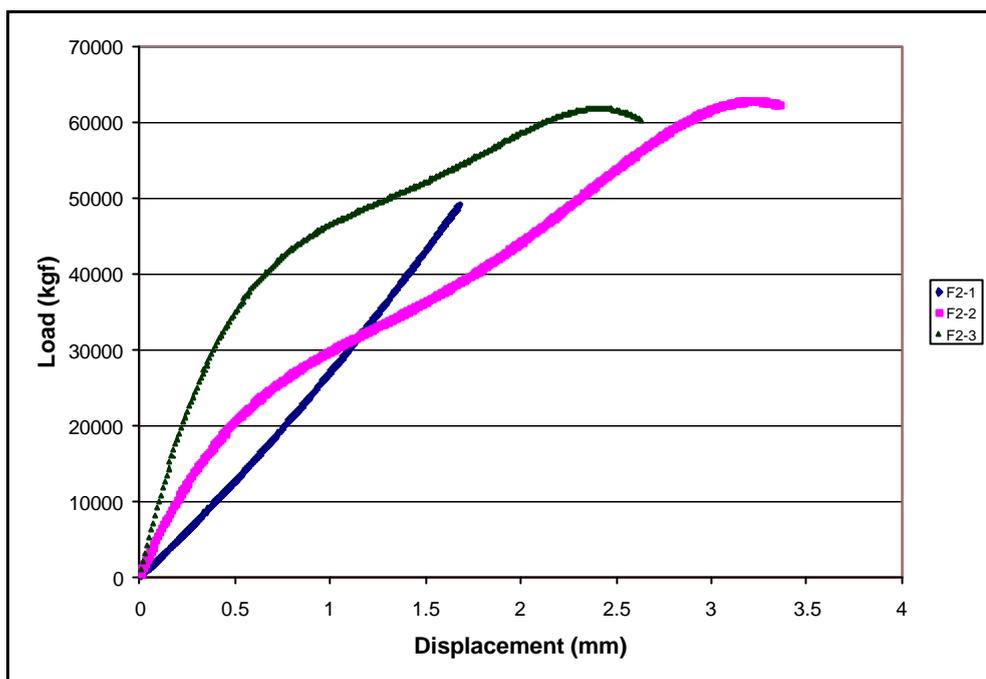
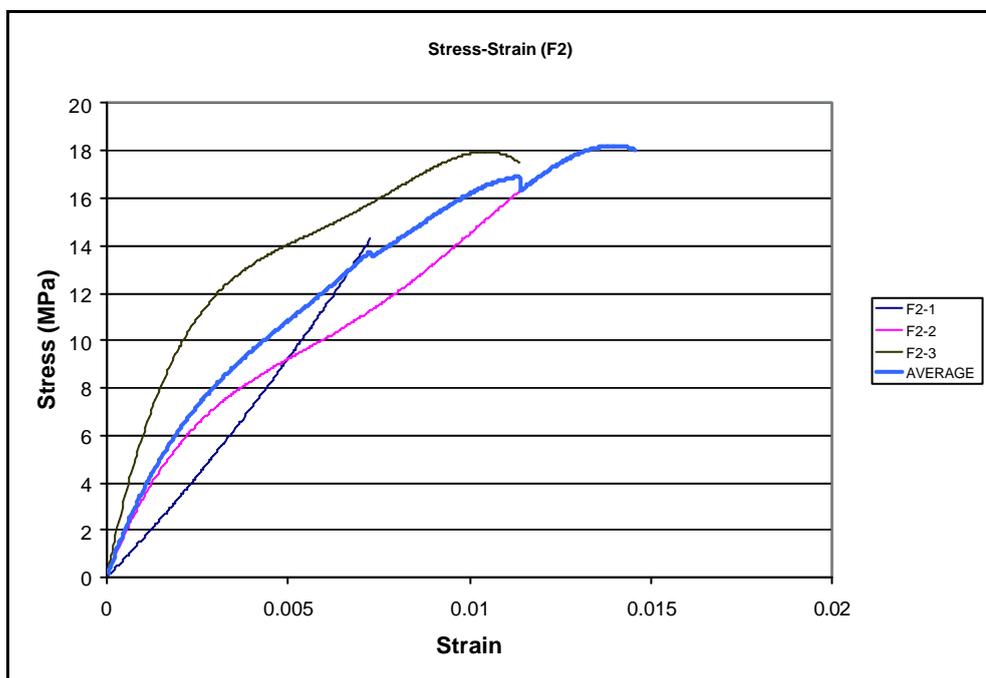
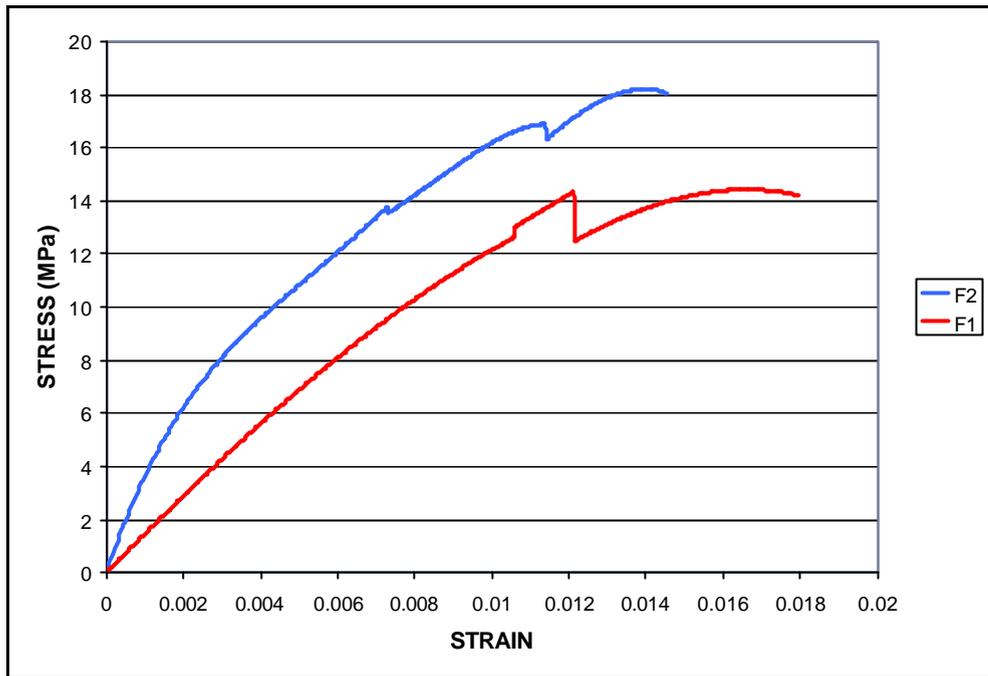
Applied load and obtained displacement were recorded. The load-displacement graphs were converted to stress-strain basis by dividing the load to initial specimen area and displacement to initial specimen height. Figure 3.26 shows the load-displacement curve of the masonry produced by F1 while stress-strain curve is illustrated in Figure 3.27. Load displacement curve and stress curve for masonry, produced by F2 are shown in Figure 3.28 and 3.29 respectively. The average s-e curves of masonry produced with two different types of mortar are also illustrated in Figure 3.30 for the sake of comparison.

Figure 3.26. Load-displacement curves for masonry specimens produced by F1 mortar

Figure 3.27. Stress-strain curves of masonry specimens produced by F1 mortar

Figure 3.28. Load-displacement curves for masonry specimens produced by F2 mortar

Figure 3.29. Stress-strain curve of masonry specimens produced by F2 mortar

Figure 3.30. Average stress-strain curves of the masonry specimens produced by F1 and F2 mortar

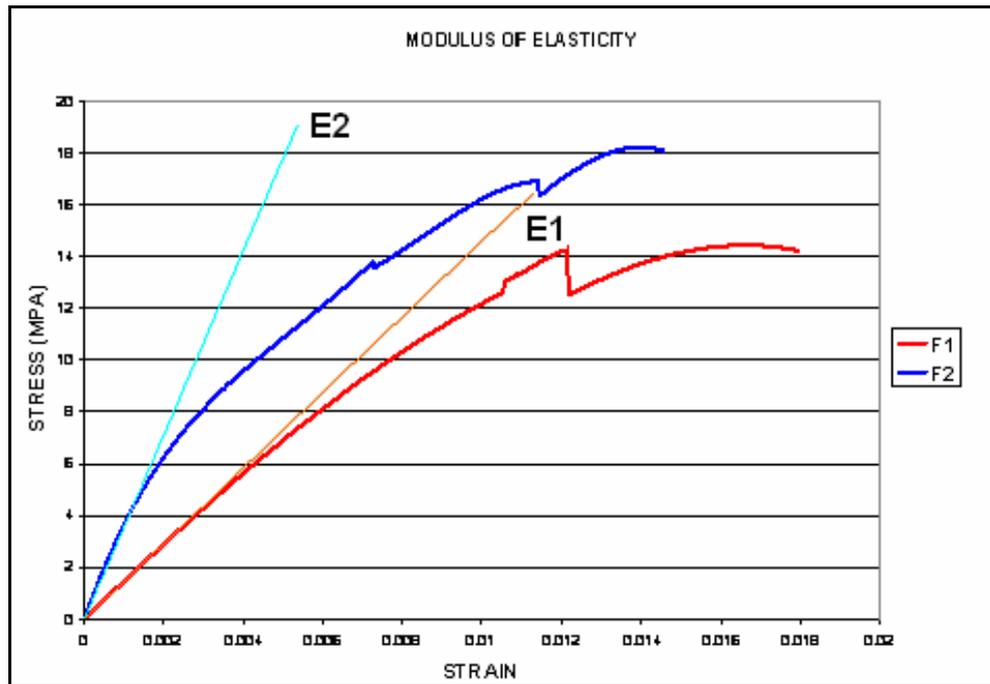
According to Eurocode-6, Design of Masonry Structures, the characteristic modulus of elasticity (E_k) is defined as a secant modulus at service load conditions, i.e. at 1/3 of the maximum vertical load [23]. Modulus of elasticity for each type of masonry calculated at the load level of 1/3 of the compression strength. Figure 3.31 illustrates the calculation. In the illustration E1 and E2 are calculated as 1455 MPa and 3545 MPa respectively.

Figure 3.31. Determination of modulus of elasticity according to EC-6

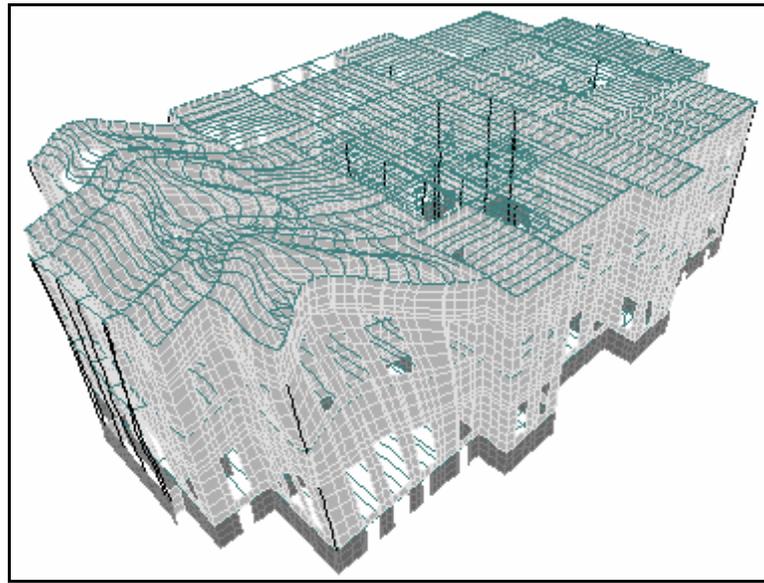
Important mode shapes of the palace are illustrated below with their period (T) and modal mass participation ratio (MPR) with movement direction. It can be said that, the first modes of the structure are related to the second and first stories of the palace while basement floor is participating in dynamic behavior through the 59th and 60th modes. This observation demonstrates the effect of the stiffness in modal behavior (Figures 4.14-4.23).

Figure 4.14. First mode shape; Movement of the left part in transversal direction

($T=0.361$ sec, $MPR=0.12$ -Y)
