**EARTHQUAKE PROTECTION OF BEYLERBEYI PALACE BY
REVERSIBLE MIXED TECHNOLOGIES**

**BOGAZIÇI UNIVERSITY
2007**

Submitted to the Institute for Graduate Studies in
Science and Engineering in partial fulfillment of
the requirements for the degree of
Doctor of Philosophy

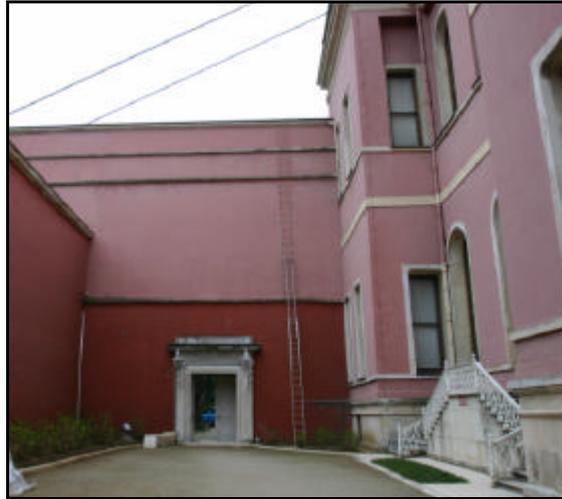
Figure 4. 24. Adjacent wall

There is a structural wall joining the structure in the transversal direction (Figure 4.24). This wall can change the all dynamic behavior of the structure. For this reason the palace should be modeled with the external wall and its effect should be searched.

In this part of the study, effect of the external wall intersecting the palace was investigated. The wall is joining the palace in the land side of the structure and separating the Harem and Mabeyn gardens. Its thickness is about 1.5 m. Figure 4.24 shows the wall.

Another important subject that should be accounted is the effect of the exterior adjacent wall (Figure 4.24) into dynamic behavior of the isolated Beylerbeyi Palace. Isolated structure has a period of 2.08 second with a horizontal displacement of 19 cm. Application requires the separation of the wall from the main structure by at least 19 cm gap.

- By the application of the strategy, the dynamic properties of the structure were totally altered. The rigid floor in the second storey causes the wall to act together. In this respect the external adjacent wall (Figure 4.24) will affect the dynamic properties of the palace adversely. For this reason the wall should be separated from Beylerbeyi Palace for the safe application of the strategy.

masonry walls can be replaced by a wall system which allows the safe application of base isolation system and does not affect the historical value and aesthetic appearance of the structure. It is important to note that, the exterior adjacent wall (Figure 4.24) must be separated from the main structure since it disturbs dynamic properties of the retrofitted structure by the application of base isolation.

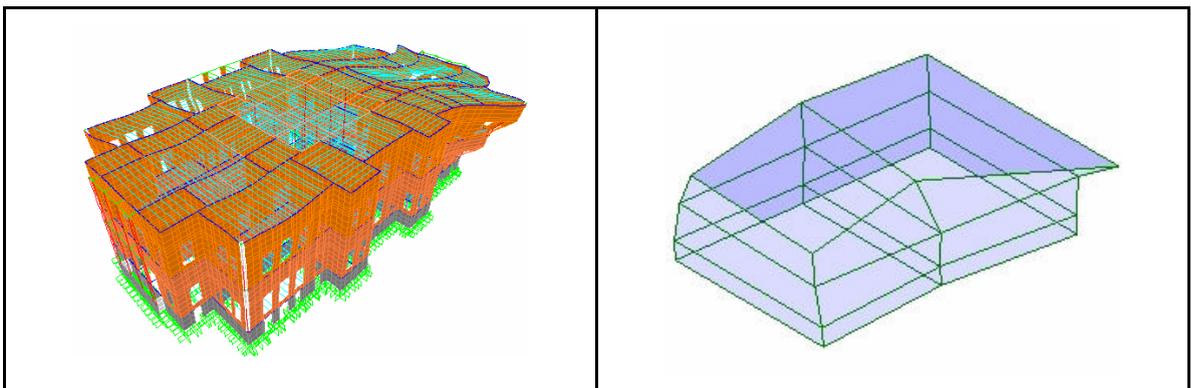
As can be seen in Figure 4.27, second mode shapes are totally different for NM and AVS results. In the NM the second mode is the movement of the right hand side while it is the longitudinal movement in AVS. For this reason, in numerical model this mode should be shifted to higher modes. This can be achieved by increasing the E of the moving part. Since the movement is in the transversal direction, only the wall along with that direction will be altered. AVS results indicate that movement of the right hand side in transversal direction belongs to fourth mode. In this respect the calibration should be performed between the second mode of the NM and fourth mode of the AVS as illustrated in Table 4.4 to shift the second mode of NM to the fourth mode of AVS

Figure 4.27. Second mode in NM and fourth mode of AVS after the first calibration.

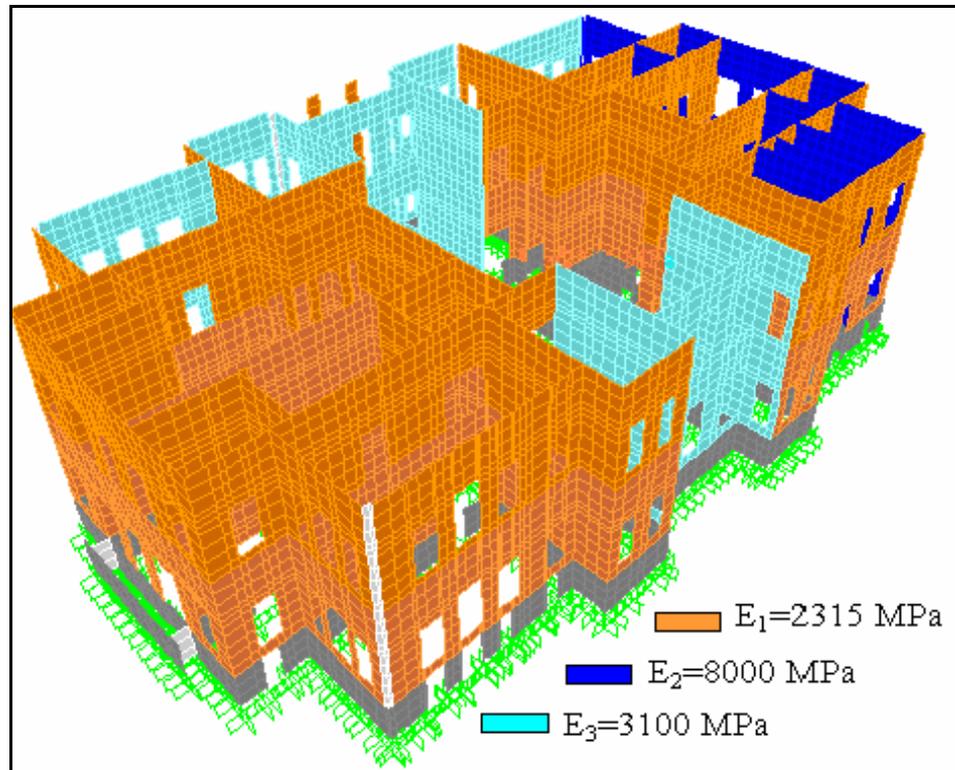
Figure 4.30. Determined modulus of elasticities

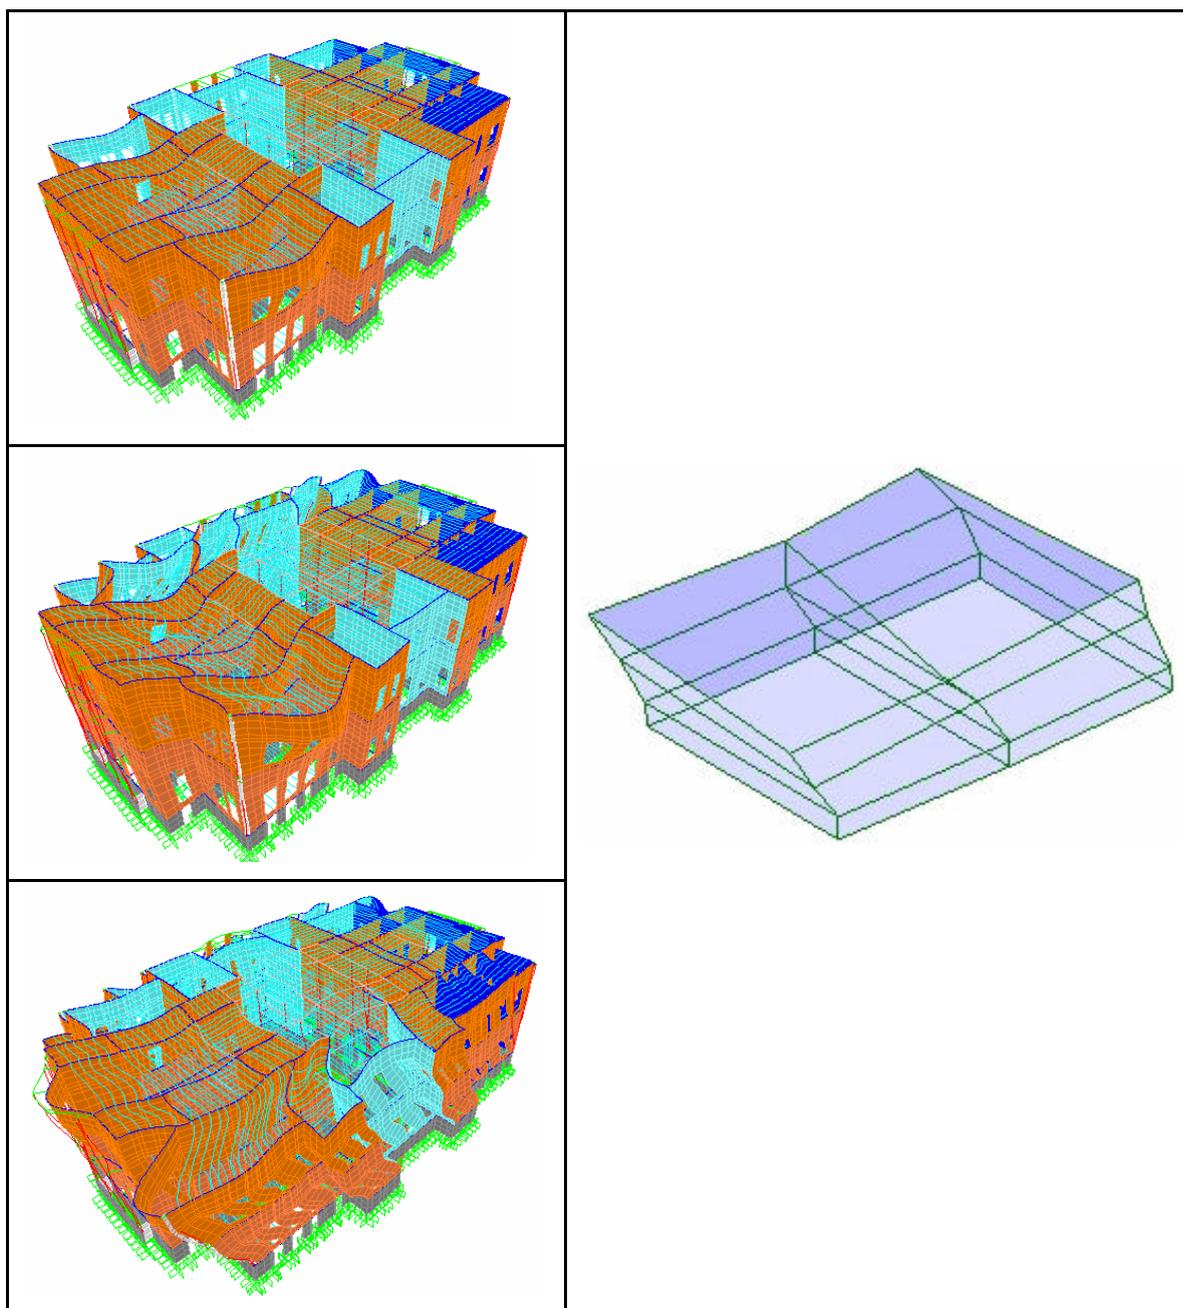
Figure 4.32. Three consecutive modes (second, third and fourth modes) of calibrated model form the second mode of AVS ($T=0.274$ Sec)

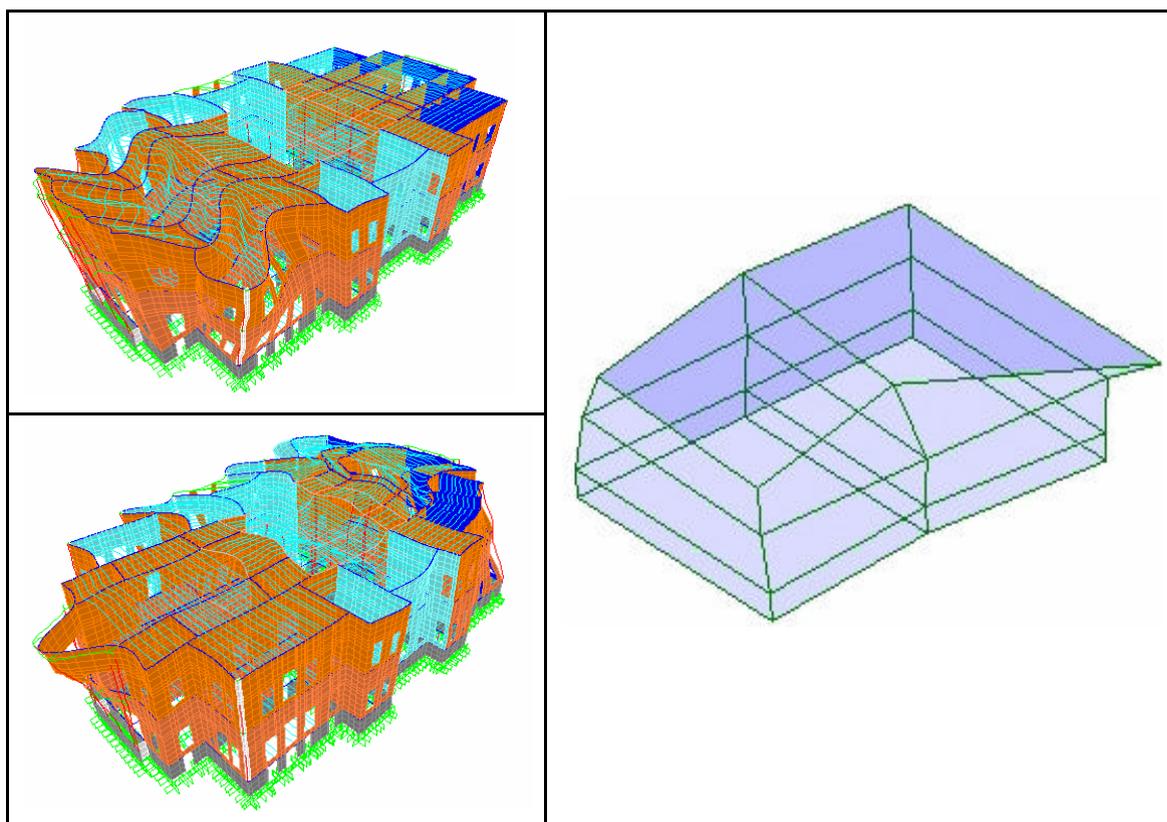
Figure 4.34. Two consecutive modes (seventh and eighth modes) of calibrated model form the fourth mode of AVS ($T=0.230$ Sec)

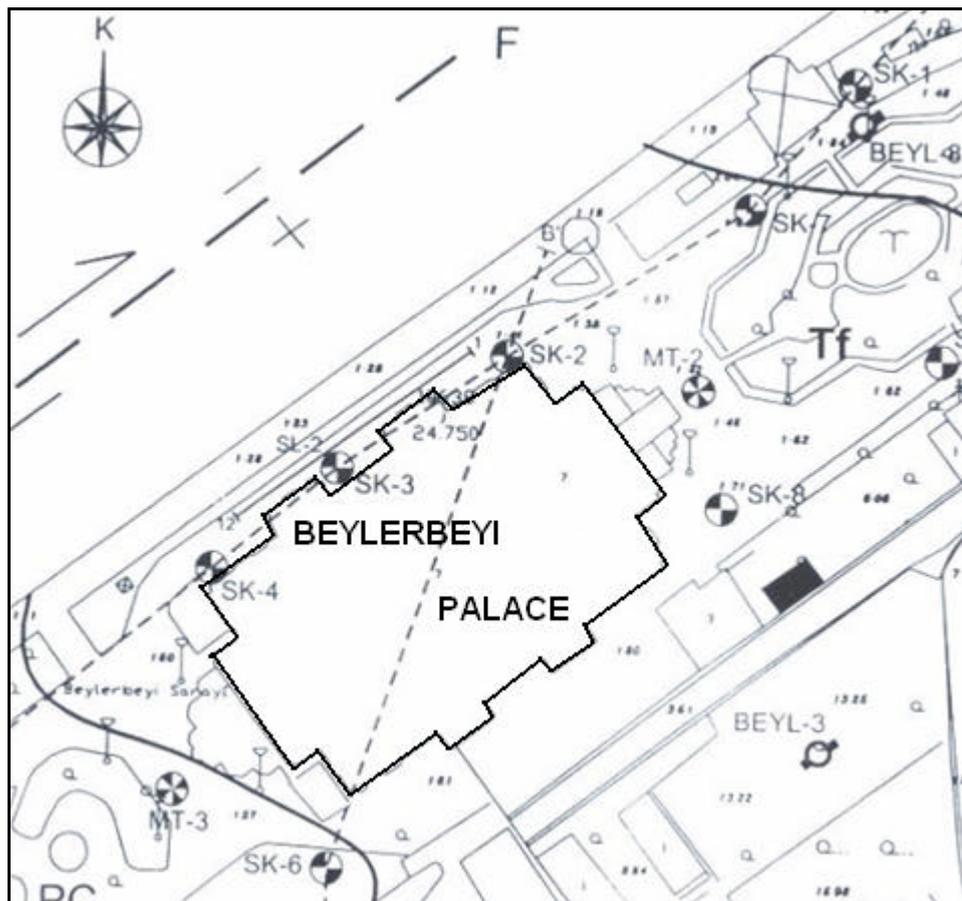
Figure 5.8 shows the locations of the mechanical drillings and seismic refraction analysis performed for the site of the main building of the palace complex [6].

Figure 5.8. Code of the Drillings and lines of Seismic Refraction Analysis [6]

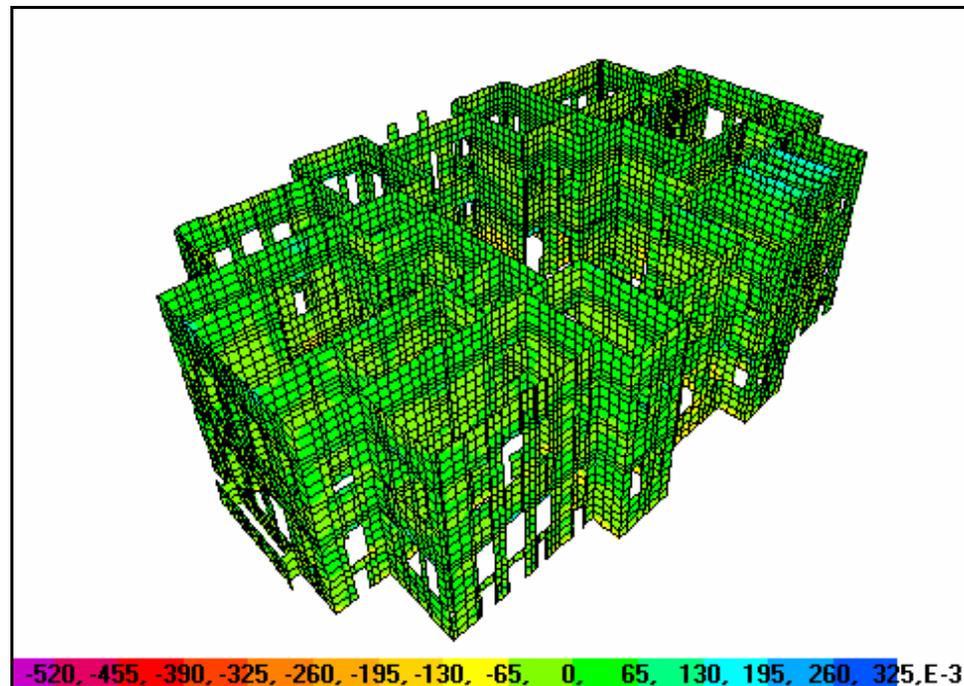
Before evaluating the stress values, developed under seismic loads, it is appropriate to search about those of under vertical loads. Dead loads, induced by the self weight of the structural elements and live load values were applied to the structure. The analyses have showed that; the stresses along with vertical and horizontal direction are quite low to conclude that the palace is safe under vertical loads. Even if the dead loads are increased by 1.4 and live loads are increased by 1.6, the safety is guaranteed. Figure 6.1 shows the horizontal stress, S11 variation in the structure while Figure 6.2 shows the vertical stresses, S22 variation. Through the structure the maximum compression stress is at around 0.5 MPa while the maximum tension stress is about 0.3 MPa. Thereby it was concluded that the structure is safe under vertical loads.

Figure 6.1. S11 stresses under vertical loads

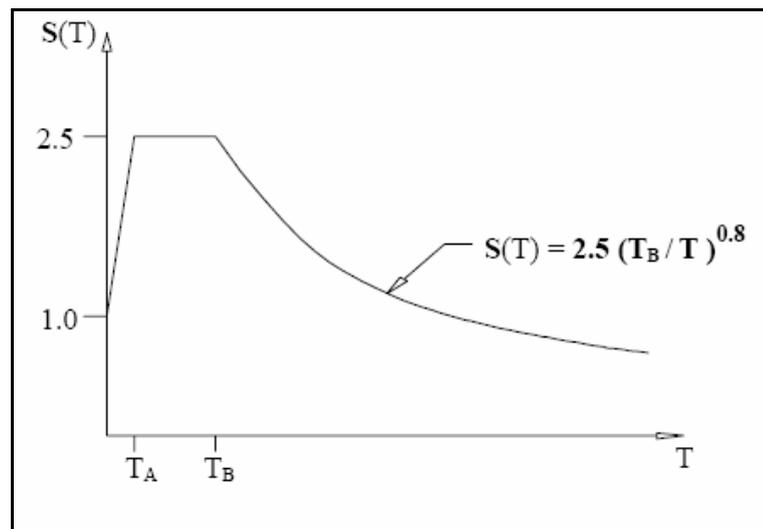
In this study three different RSA will be performed. The first analysis is based on Turkish Earthquake Code. The code gives the response spectrum according to earthquake zone of the structure and soil type of the region on which the structure sits (Figure 6.3) [7]. The required parameters had been given in chapter 5 for Beylerbeyi Palace.

Figure 6.3. Turkish Earthquake Code based response spectrum [7]

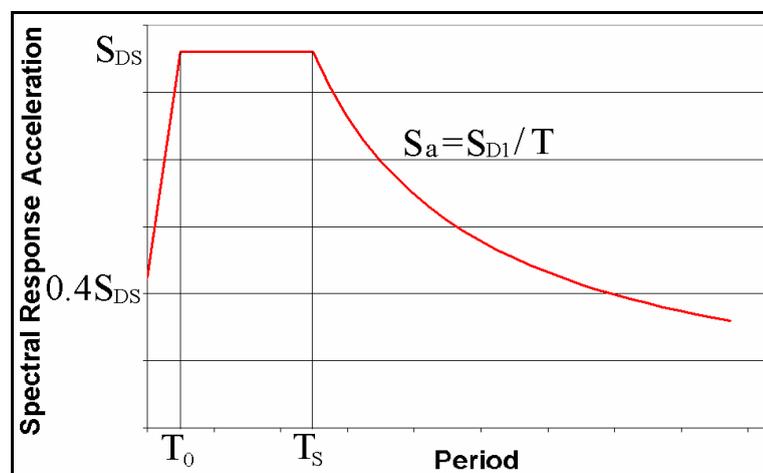
The second and third RSA will be performed according to Design Earthquake (DE) and Maximum Considered Earthquake (MCE) [8]. NEHRP based response spectrum would be used [33]. The required values were obtained from site specific hazard assessment, explained in the third chapter and they are the spectral acceleration values at 0.2 s and 1 s periods. The study has accounted the regional seismicity and geology, the expected recurrence rates and maximum magnitudes of events on known faults and source zones, the location of the site with respect to these, near source effects if any, and the characteristics of subsurface site conditions. The construction of the response spectrum is summarized in Figure 6.4 [33].

Figure 6.4. Construction of the response spectrum (33)

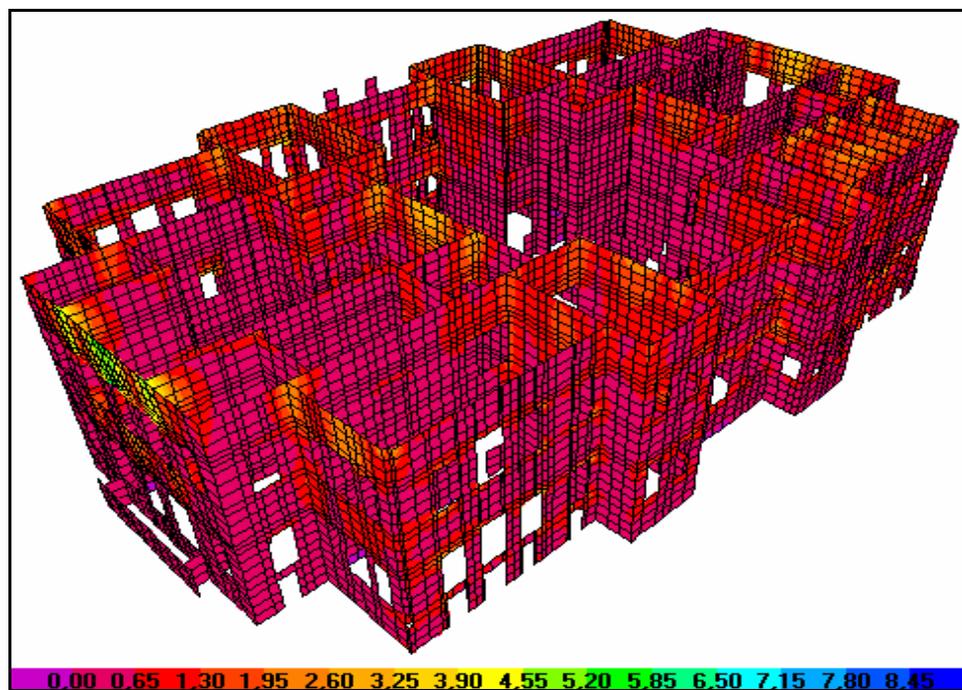
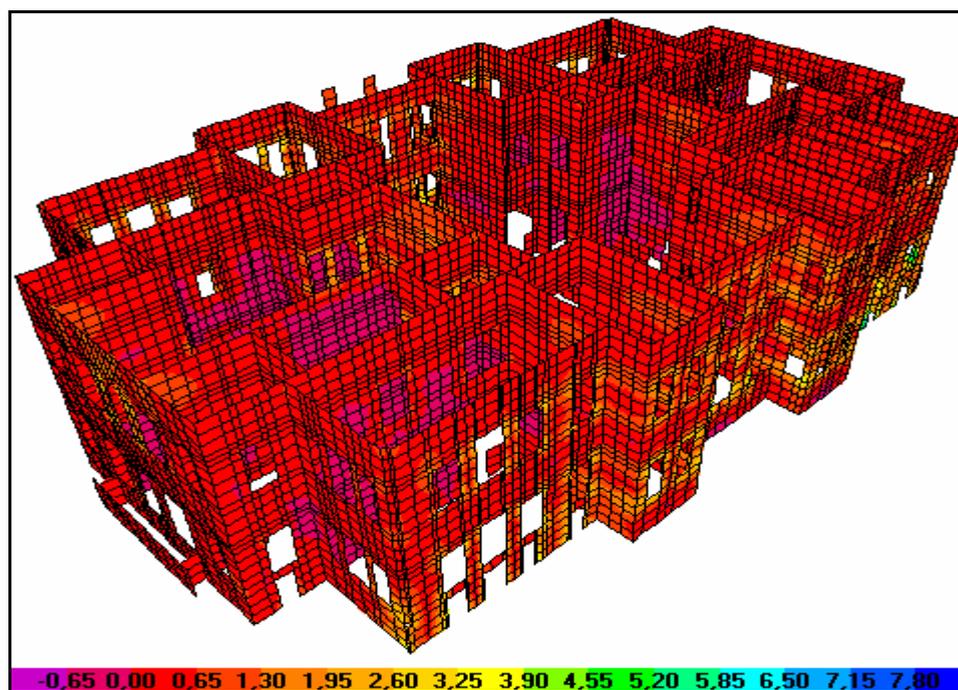
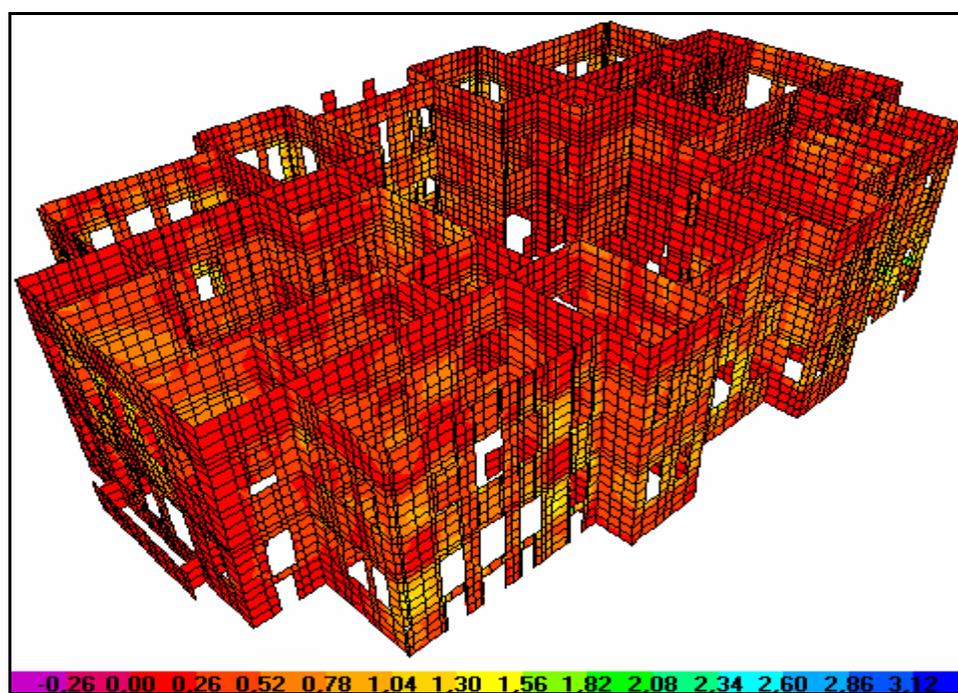
Figure 6.6. S11 stresses under RSA according to TEC, in longitudinal direction

Figure 6.7. S22 stresses under RSA according to TEC, in longitudinal direction

Figure 6.8. S12 stresses under RSA according to TEC, in longitudinal direction

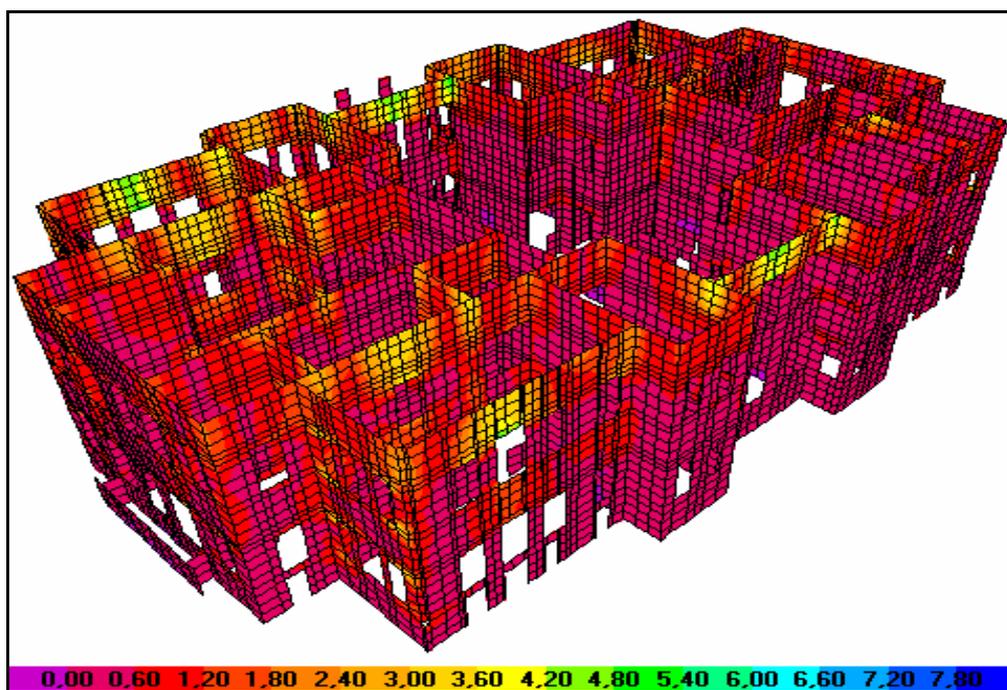
Figure 6.9, 6.10 and 6.11 shows the S11, S22 and S12 stresses for the combined effect of the vertical loads and RSA along with the transversal direction. The same interpretations are valid for the application of RSA along with transversal direction as those of longitudinal directions. Again the critical stress direction was identified as horizontal direction. In order to have a clear illustration S22 and S12 stresses were plotted to the two dimensional illustration belongs to external sea side of the structure.

Figure 6.9. S11 stresses under RSA according to TEC, in transversal direction

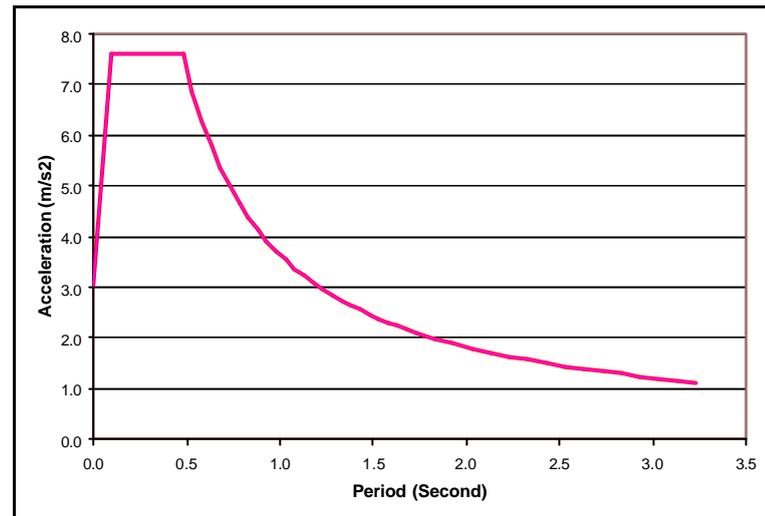
The earthquake, has 10% chance of exceedance in 50 years is defined as the design earthquake [8-9]. The response spectrum is illustrated in Figure 6.12. In the construction S_{D1} and S_{DS} values were obtained as 0.371g and 0.773g respectively [1].

Figure 6.12. Response Spectrum obtained for Design Earthquake

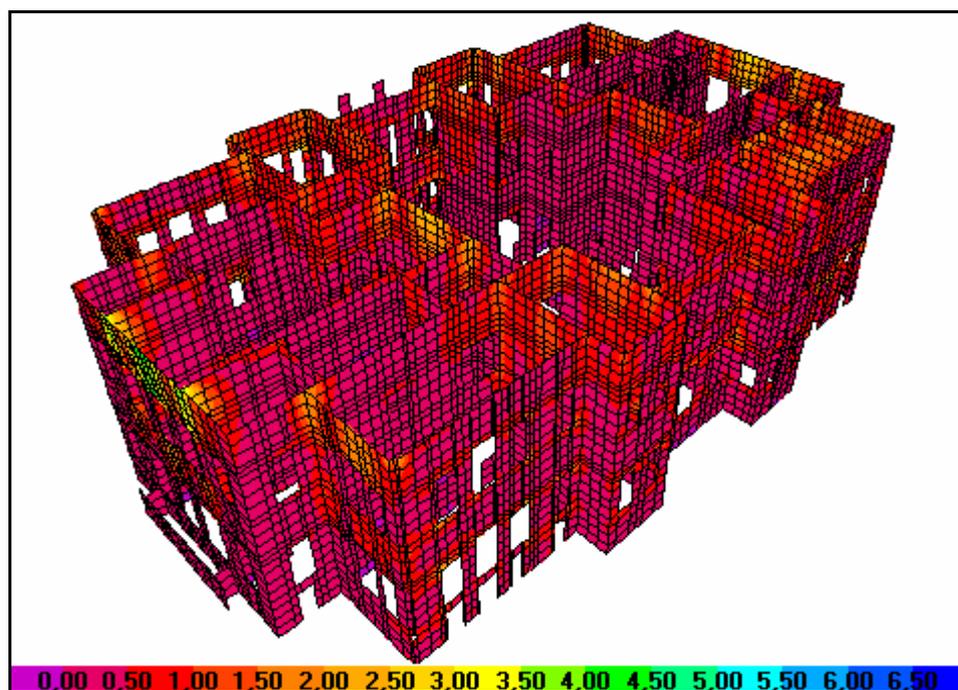
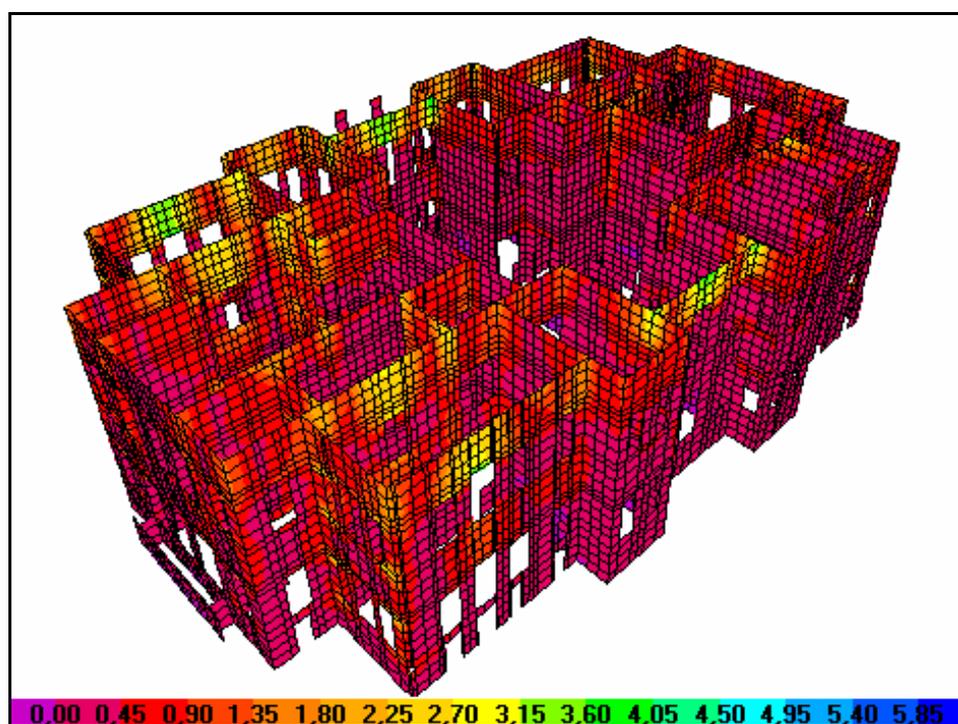
Figure 6.13. S11 stresses under RSA of DE in longitudinal direction

Figure 6.14. S11 stresses under RSA of DE in transversal direction

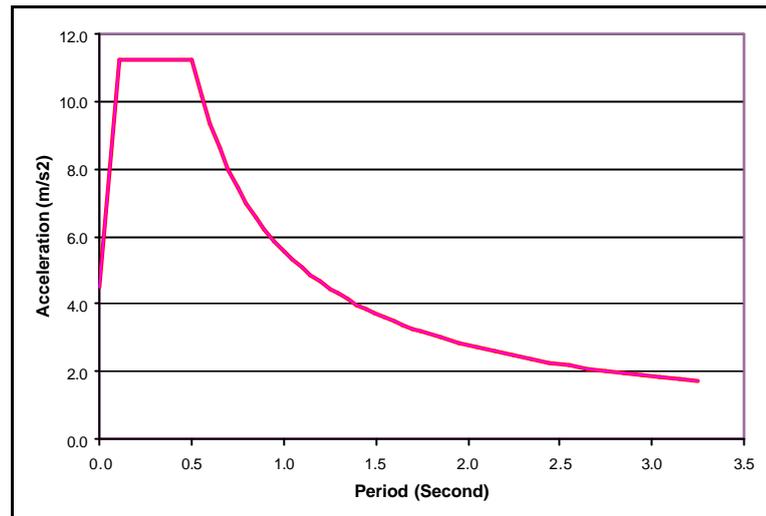
Figure 6.15. Response Spectrum obtained for Maximum Considered Earthquake
MCE

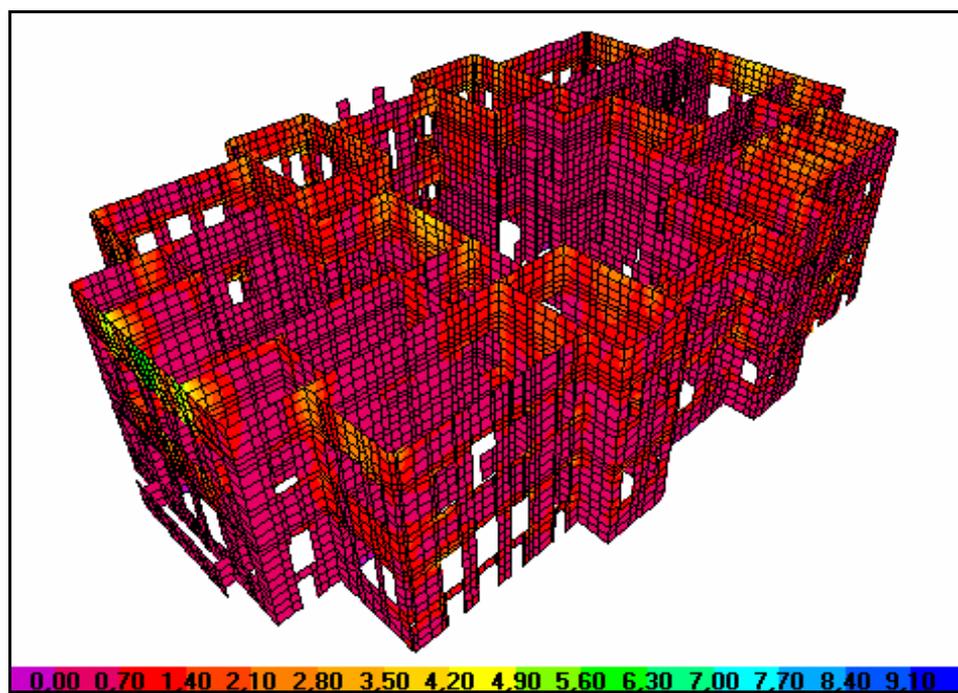
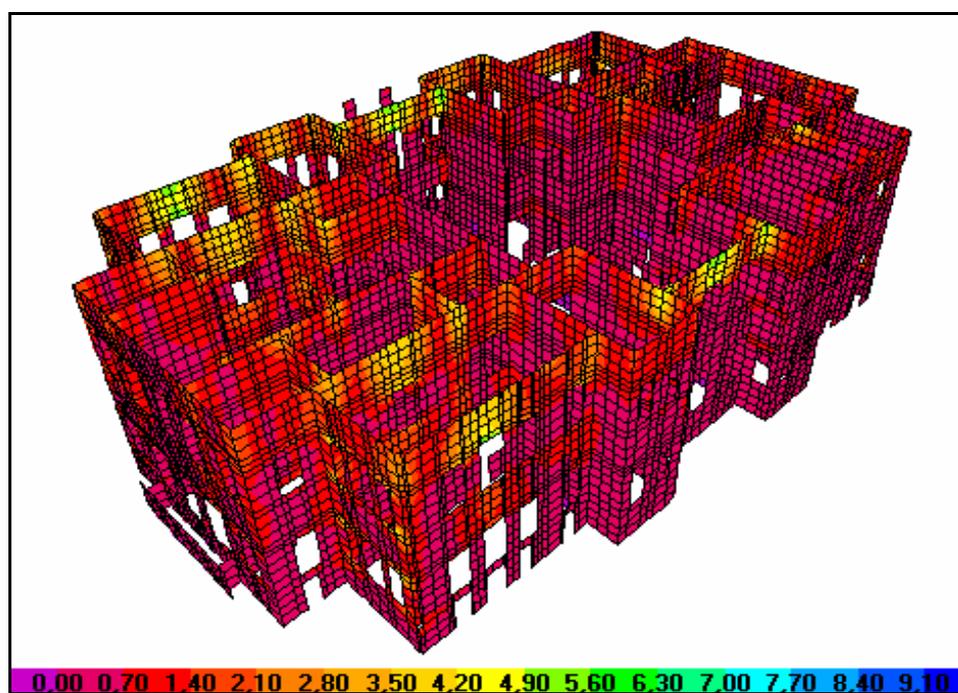
Figure 6.16. S11 stresses under RSA of MCE in longitudinal direction

Figure 6.17. S11 stresses under RSA of MCE in transversal direction

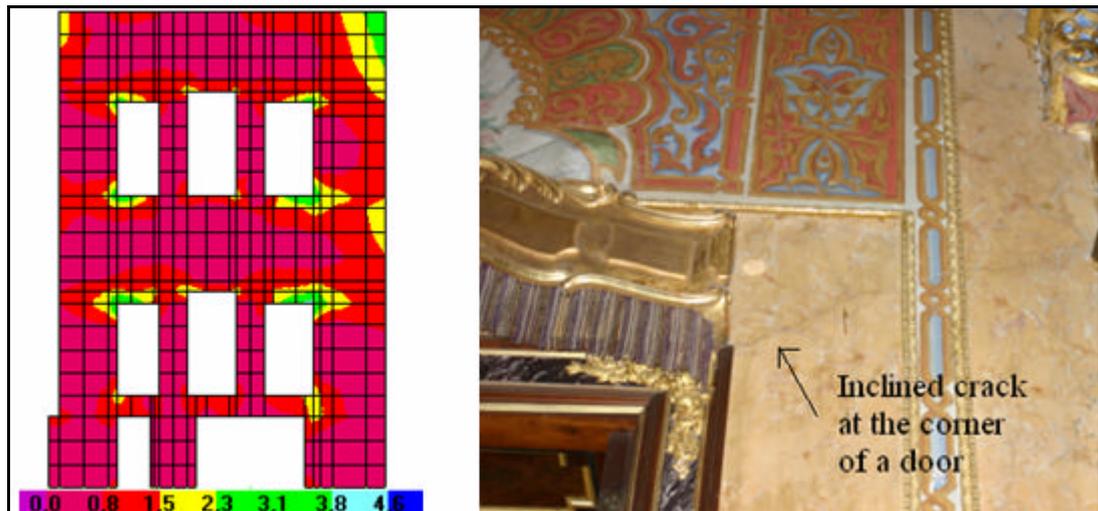
Figure 6.19. Stress concentrations at the corner of openings and a corner crack from the structure

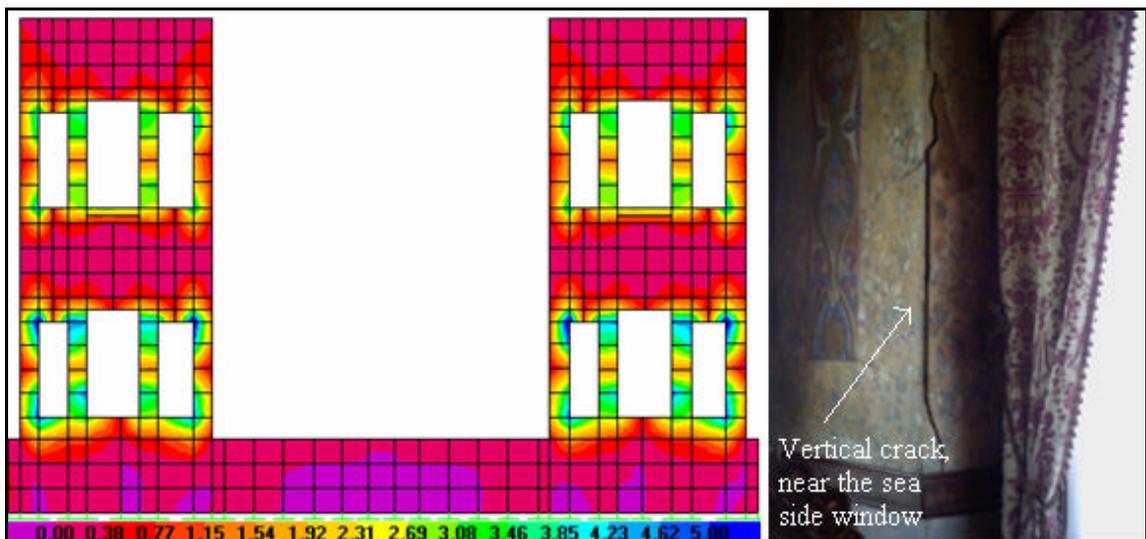
Figure 6.20. Vertical stress concentration and respective crack from the structure

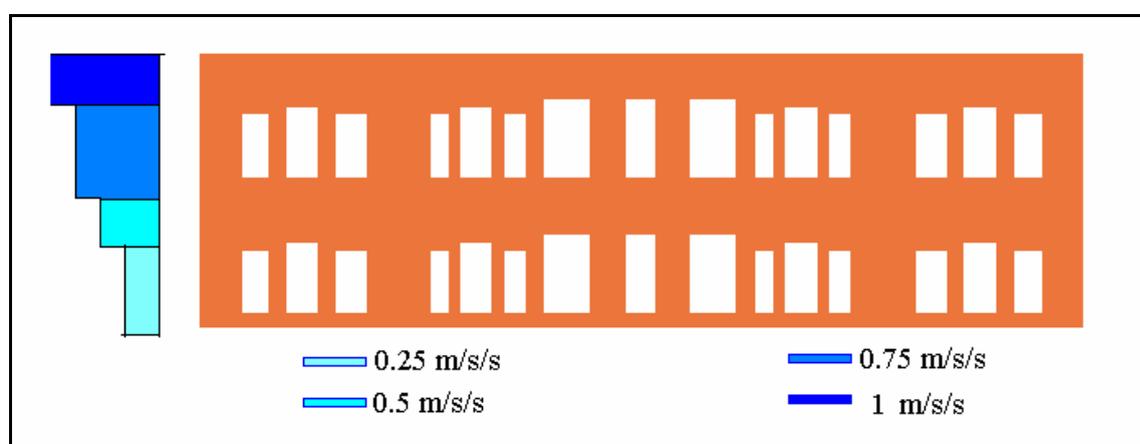
Figure 7.1. Application of the horizontal loads

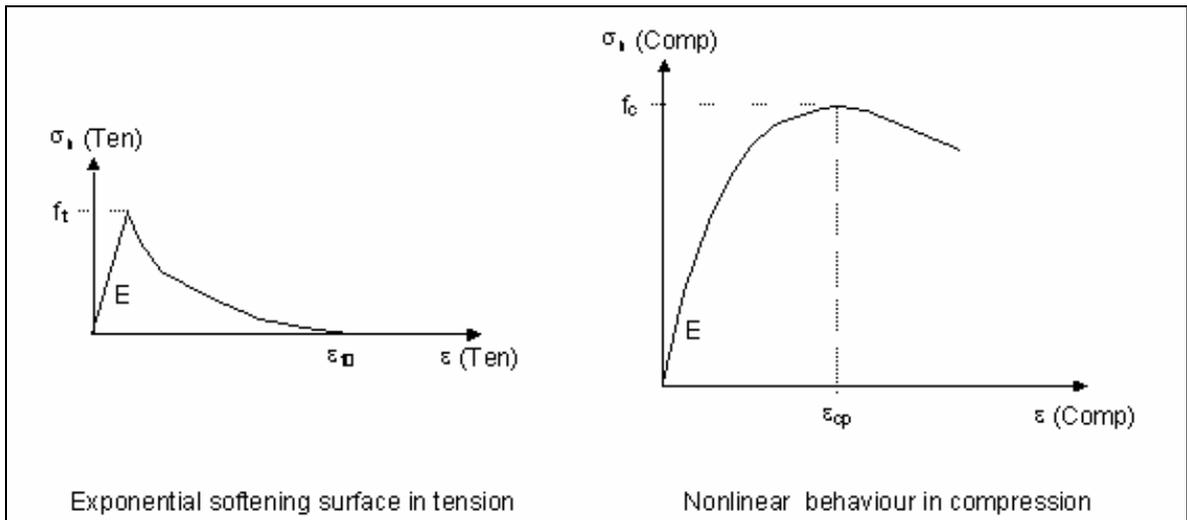
Figure 7.2. Nonlinear material properties for CCCM [28]

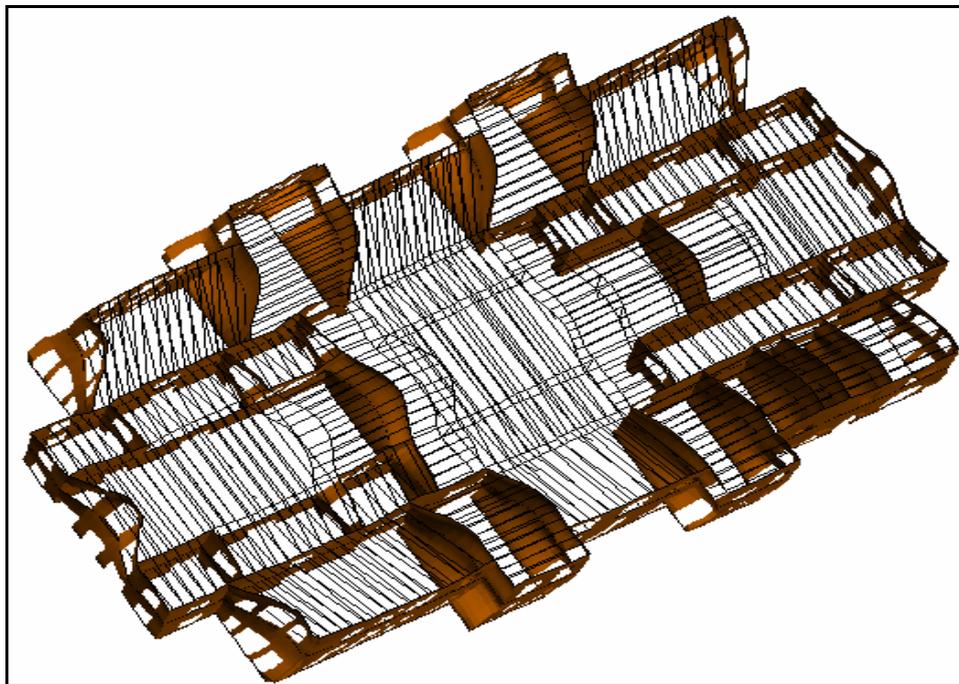
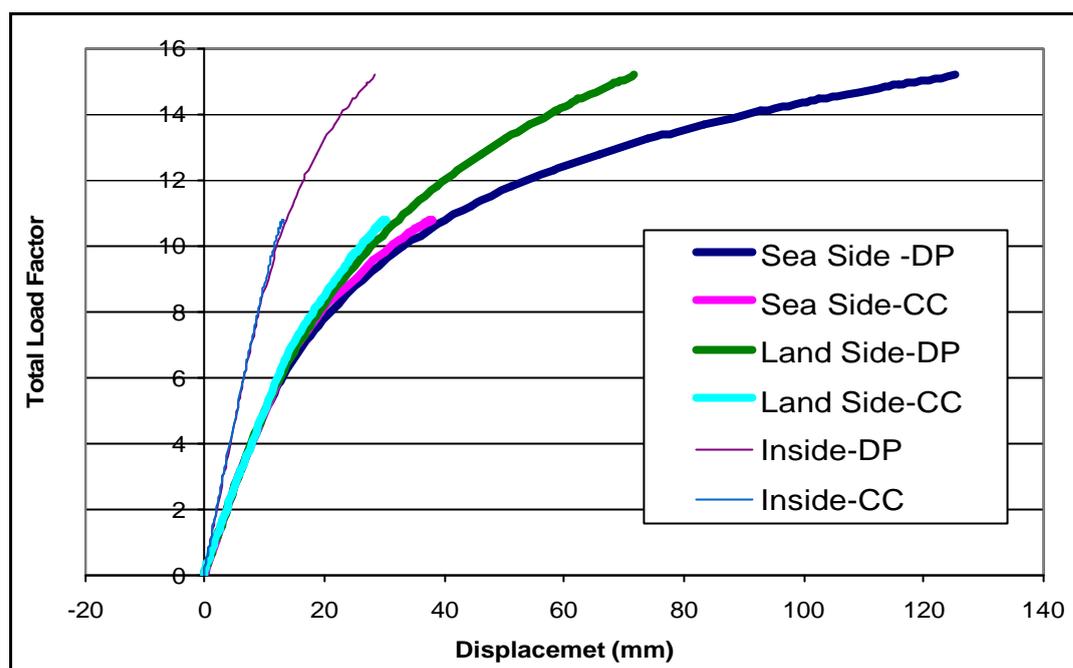
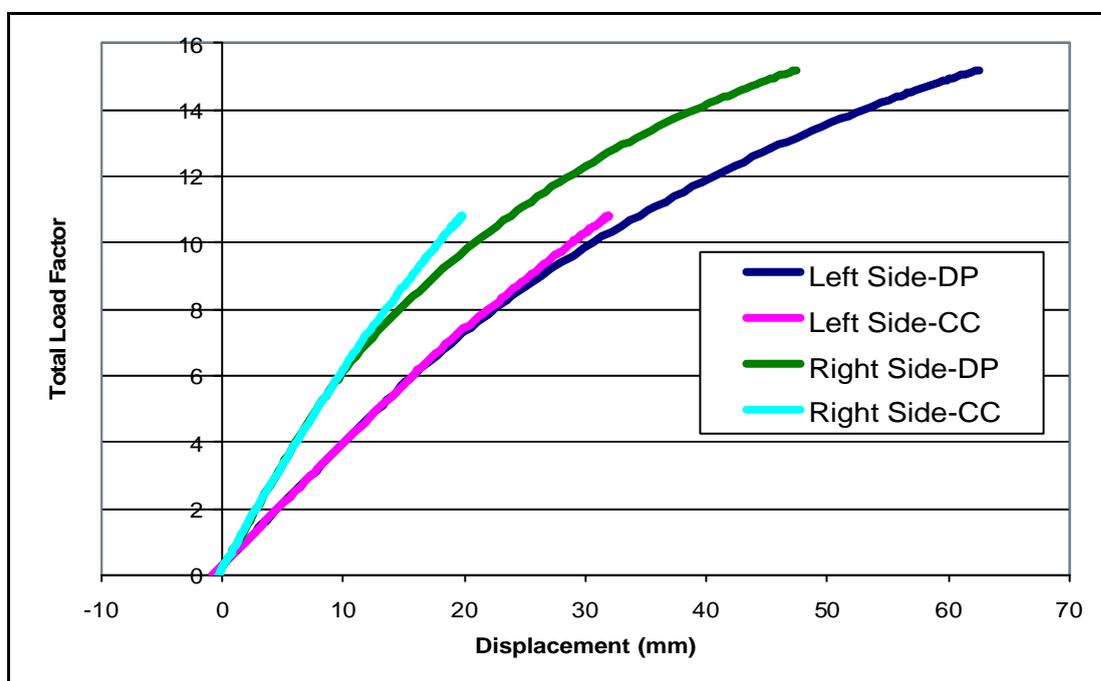
Figure 7.4. Deformed shape of the palace after pushover analysis in longitudinal direction

Figure 7.5. Pushover curves for the walls loaded by in-plane loads along with longitudinal direction

Figure 7.6. Pushover curves for the walls loaded by out of plane loads along with longitudinal direction

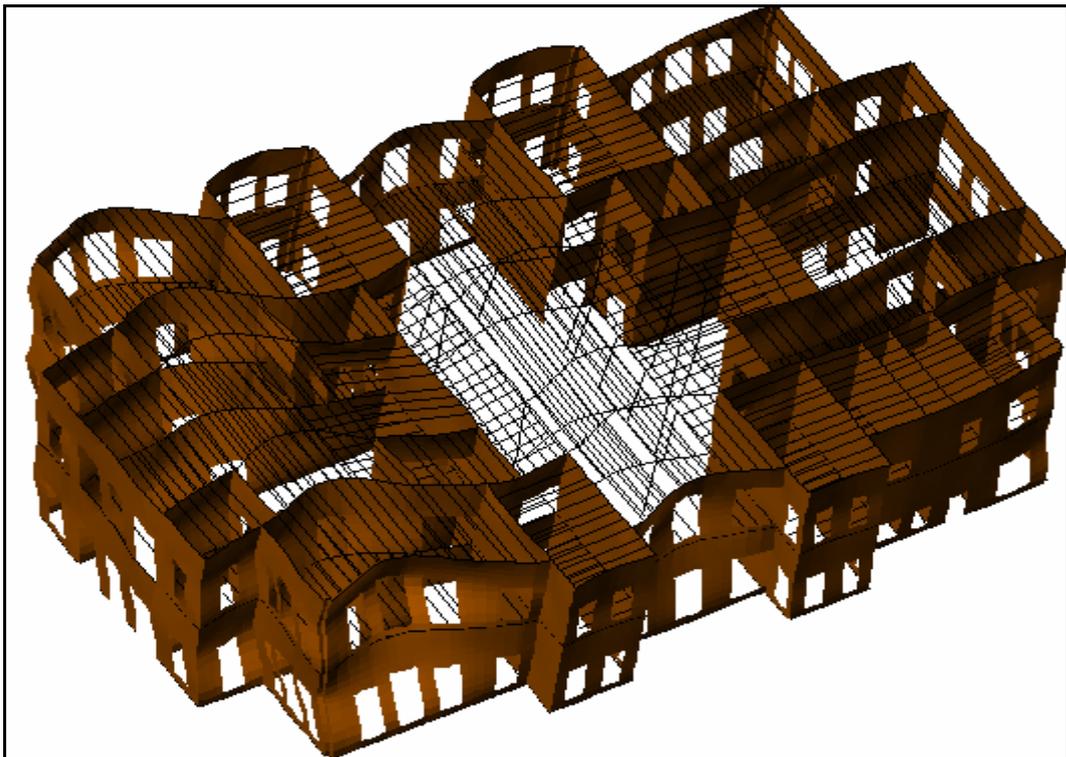
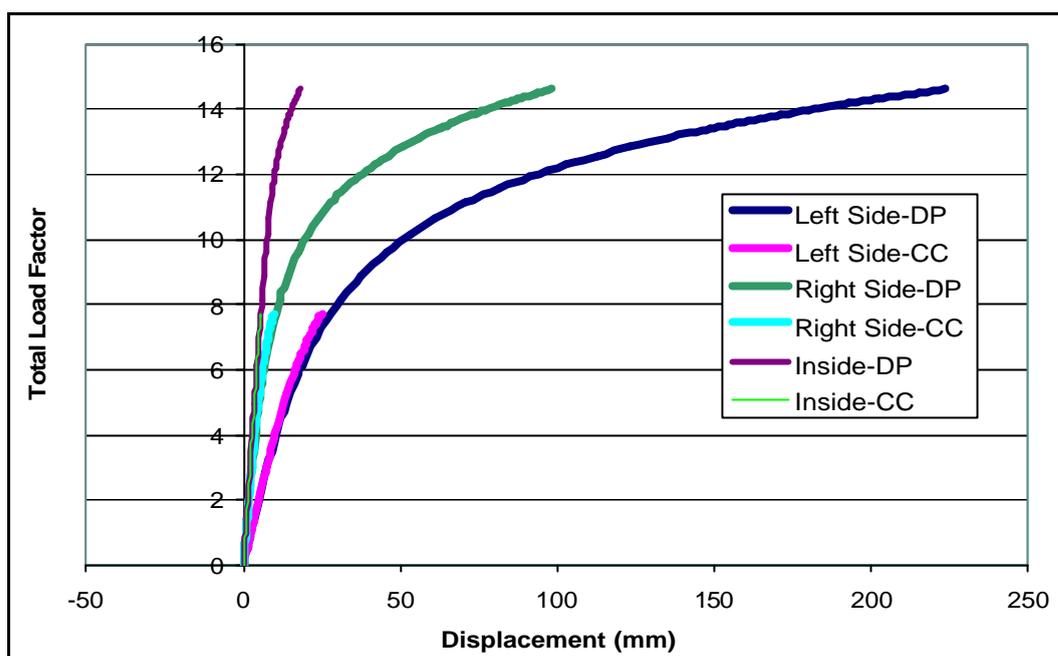
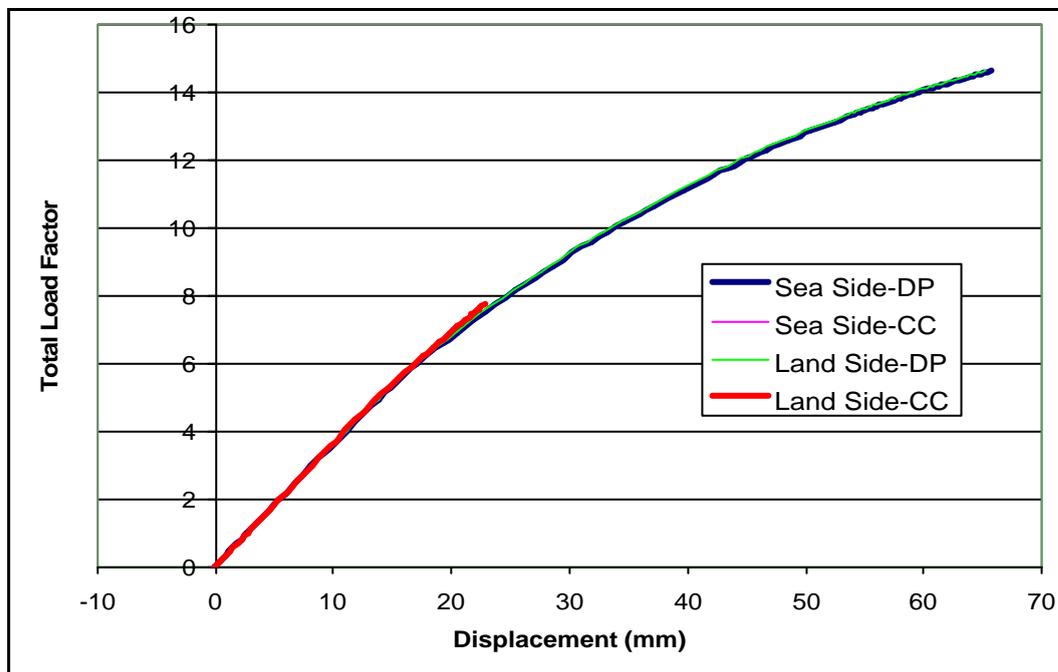
Figure 7.7. Deformed shape of the palace after pushover analysis in transversal direction

Figure 7.8. Pushover curves for the walls loaded by inplane loads along with transversal direction

Figure 7.9. Pushover curves for the walls loaded by out of plane loads along with transversal direction

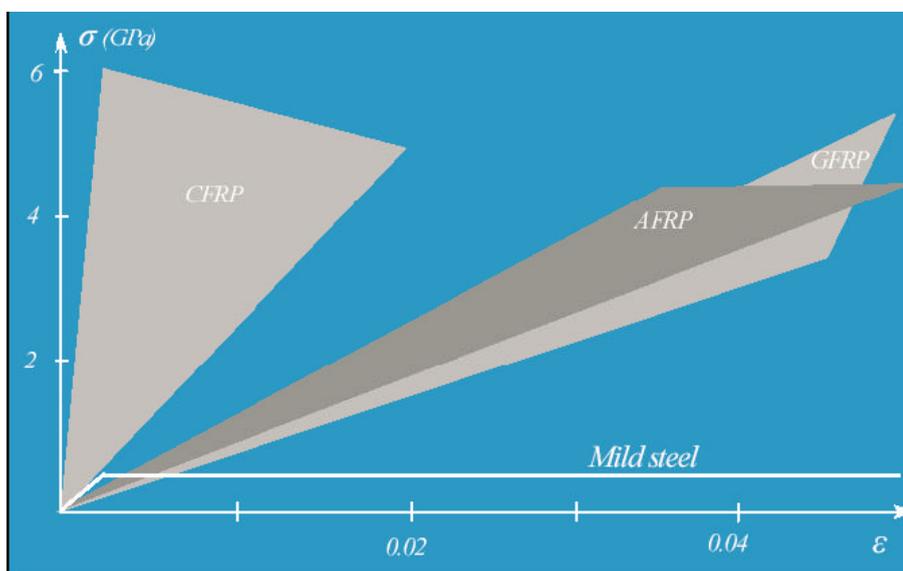
Figure 8.1. Stress-strain relationship of different FRPs [41]

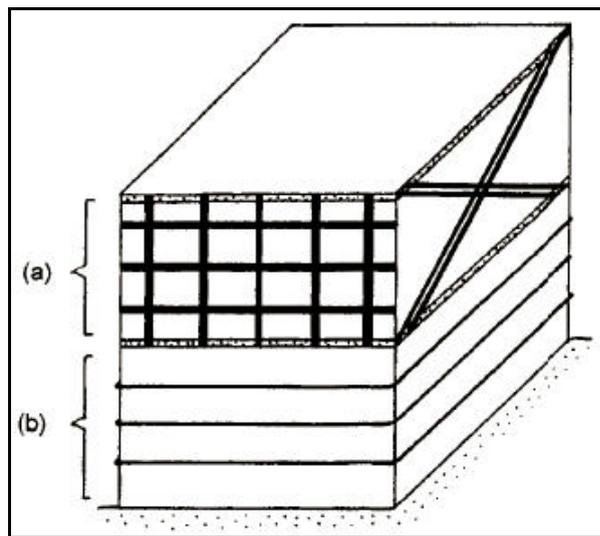
Figure 8. 3. Strengthening of masonry with FRP (a) bonded strips to improve flexural and in-plane shear strength, (b) circumferentially applied unbonded strip-like tendons, providing confinement [40].

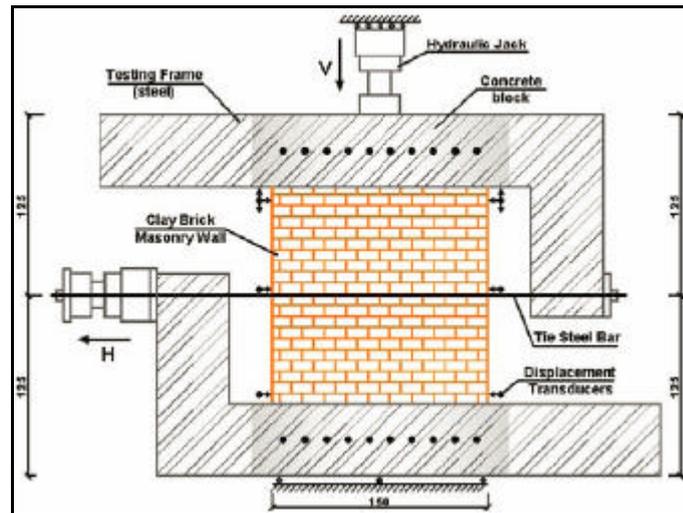
Figure 8. 4. The specimen test set-up [45]

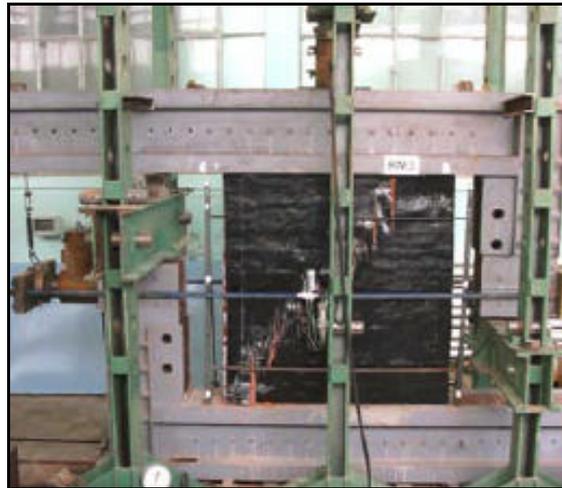
Figure 8. 5. The tested RM3 wall (vertical applied CFRP) [45]
