**EARTHQUAKE PROTECTION OF BEYLERBEYI PALACE BY
REVERSIBLE MIXED TECHNOLOGIES**

**BOGAZIÇI UNIVERSITY
2007**

Submitted to the Institute for Graduate Studies in
Science and Engineering in partial fulfillment of
the requirements for the degree of
Doctor of Philosophy

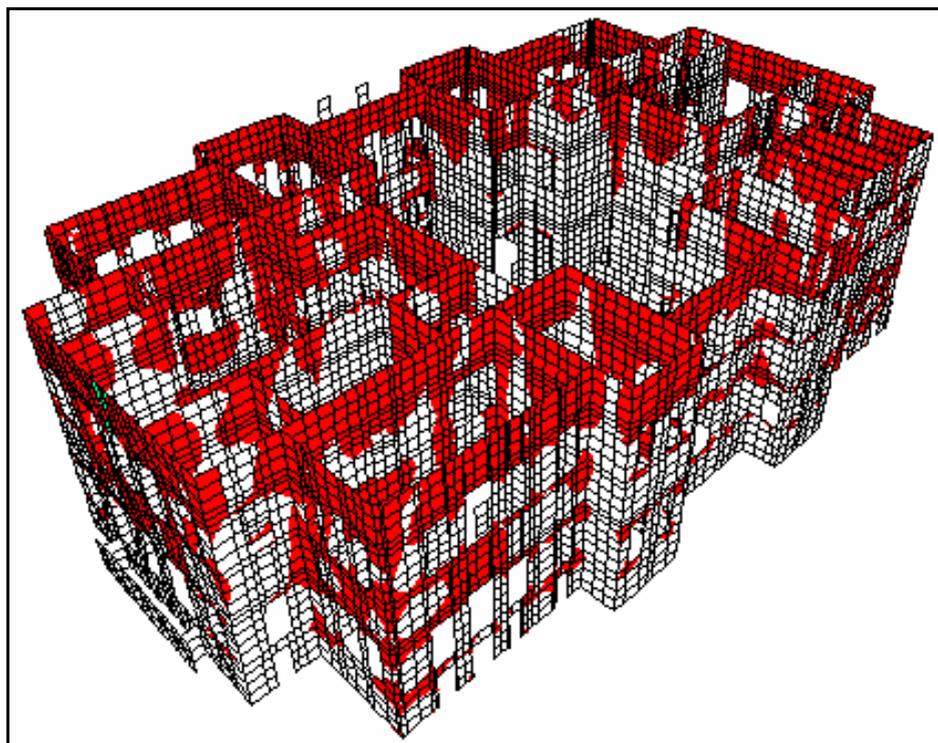
Figure 8.8. Critical regions with respect to horizontal stresses according to TEC

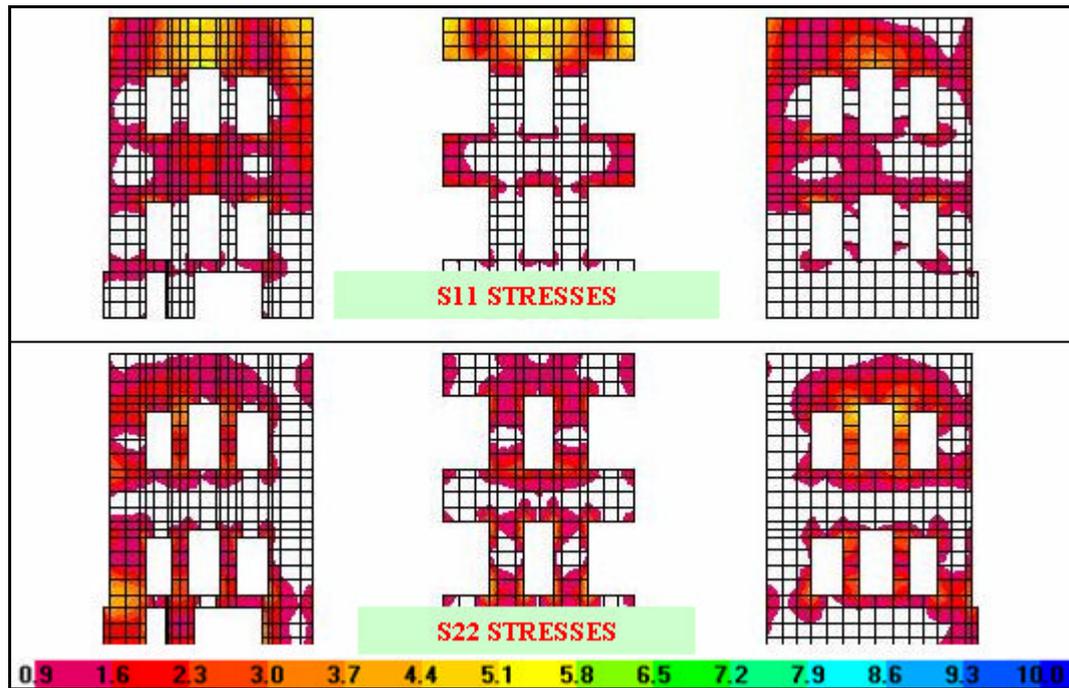
Figure 8. 15. Critical regions with respect to horizontal and vertical stresses under MCE for external sea-side walls

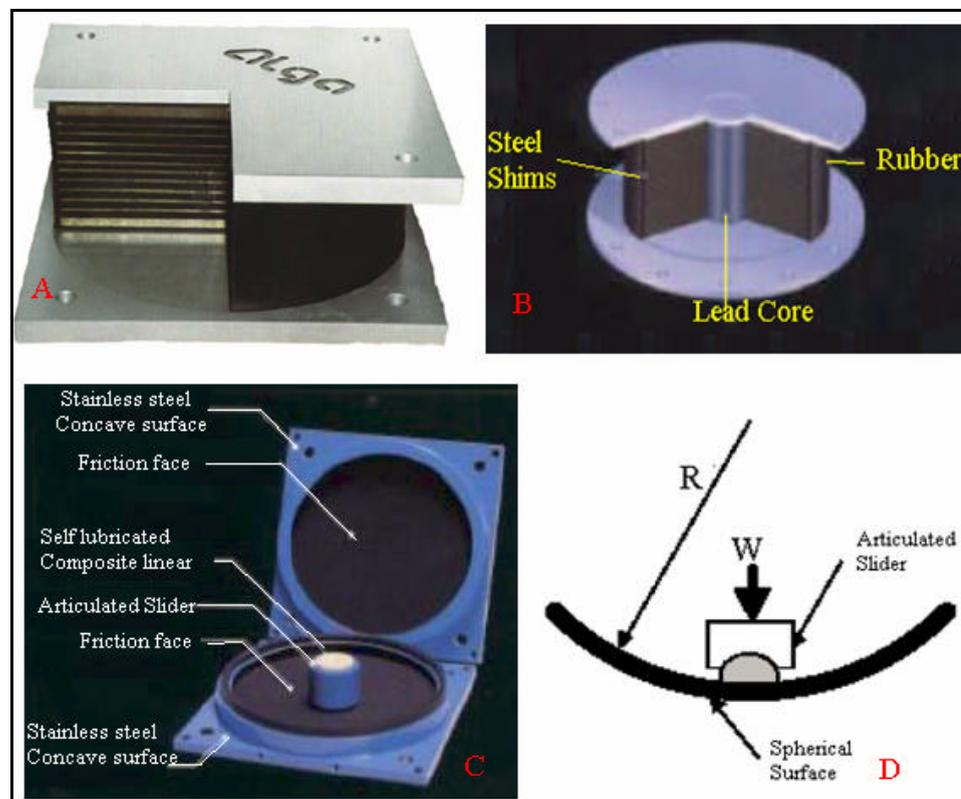
Figure 8. 16. Base isolation devices (A : HDRB, B:LRB, C, D : FPS)

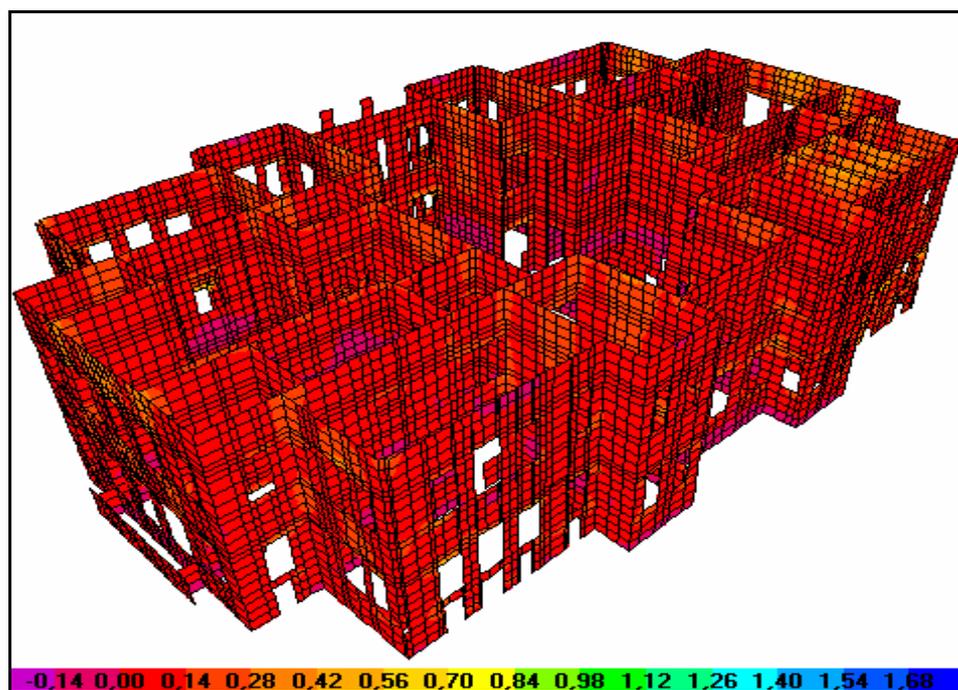
Figure 8.22. S11 stresses under RSA of MCE in longitudinal direction for isolated Beylerbeyi Palace with HDRB

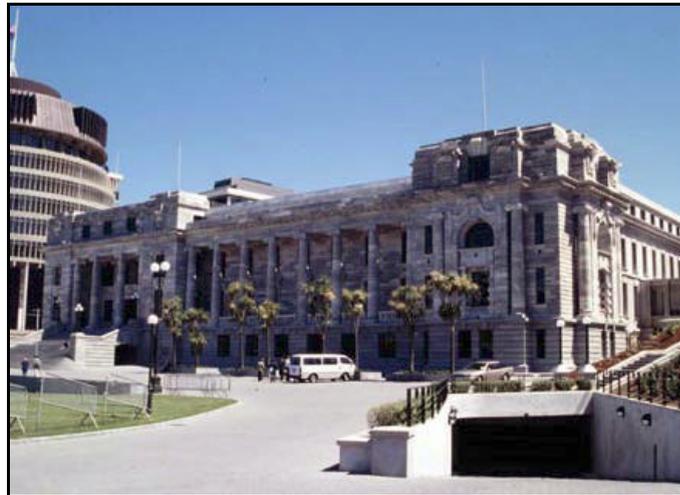
Many new buildings has been equipped with base isolation systems and also many existing buildings of historical importance has were seismically upgraded by means of seismic isolation (like City and County Building in Salt Lake City, Utah (USA) and Parliament House, Wellington (NZ), see Figure 8.24 and 8.25) [41].

Figure 8.24. Parliament House, Wellington (Seismic retrofit, 1994) [40]

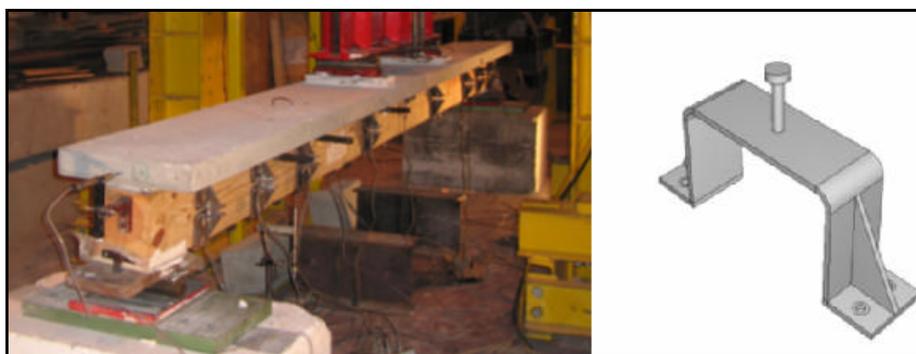
Within the framework of this study no detail would be given except application of the concrete over timber beams. These details belong to a study named as “Innovative steel connection for a composite timber – steel – concrete slab system” [46]. In the study steel devices were used as connector between the timber and concrete. Two point loads are applied and performance of the composite beams with different connectors are tested (Figure 8.26).

In order to work as a rigid diaphragm the concrete slab should have at least 7 cm thickness and should also be connected to masonry walls appropriately [special communication with J. M. Proenca].

Figure 8. 26. Application of concrete over timber beams with steel connector [49]
